# Confidential Home Inspection Report

Prepared for: **Concerned Home Buyer**

**Condo Street  
Seattle, WA 98000**

**February 29, 2016**

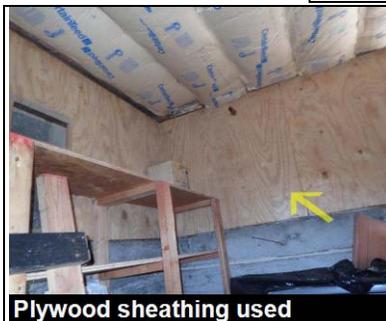
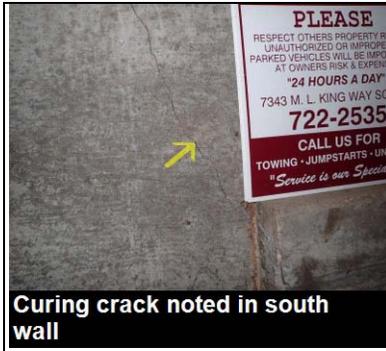
Overall Condition- Appears serviceable; No apparent structural defects noted at the time of the inspection.  
Cracking/fractures noted in the foundation stem wall; these do not appear to be significant at the time of the inspection. Typically cracks of this type are associated with curing of the concrete (during the first few years after construction) or normal ground movement. (Note: Crack is visible in the crawl space, but not on the exterior of the wall)

Curing crack noted in south wall

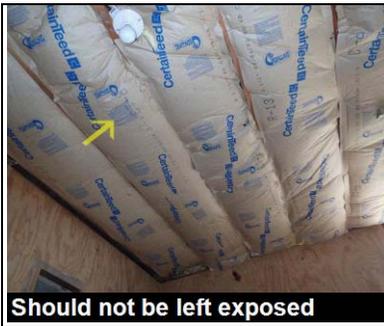
Ventilation:	Two vent openings for this larger crawl space area; vent opening appear to be slight clogged with debris also. Consider adding more ventilation.
Sub-Floor Insulation:	Sub-floor insulation appears to be improperly installed; Kraft-paper backed sub-floor insulation is exposed; this material is not designed to be left exposed (as noted by most Manufacturer's of the product) and is a potential fire hazard. Recommend removing and replacing the sub-floor insulation with an approved material. Recommend contacting a qualified, licensed insulation specialist about the replacement of the sub-floor insulation.

Should not be left exposed

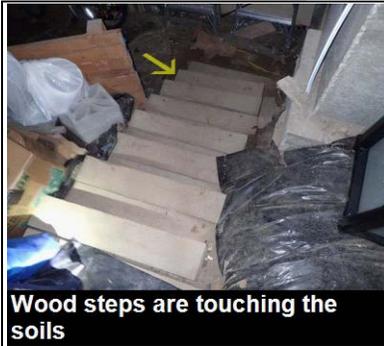
The wood steps used in the crawl space area are not pressure-treated lumber and will be prone to rot damage where steps make contact with the soils.  
 One of the mid-level retaining walls does not appear to be pressure-treated lumber and will be prone to rot damage over time.

Wood steps are touching the soils

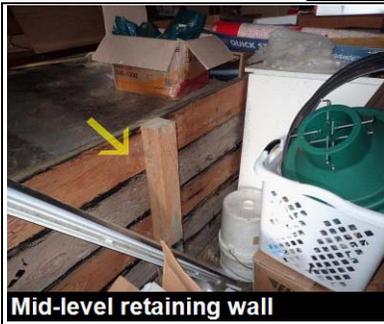
Mid-level retaining wall

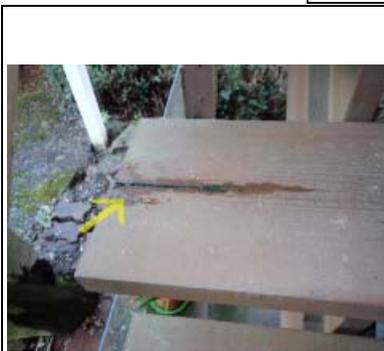
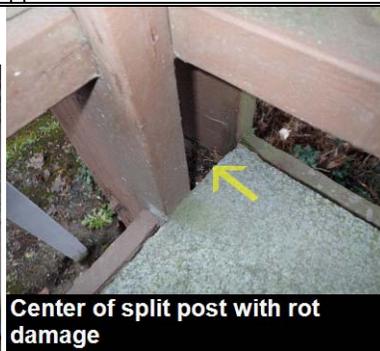
Evidence of fungal rot decay/damage to structural components of the exterior porch/stairs structure, located at/in (but not limited to): the steps/stairs, railings and structural posts. The 4x spacer between the split posts with fungal rot damage at two locations. The damage, to the wood members/materials noted in the porch/deck, appears to be **moderate**, at the time of the inspection, with possible hidden damage to some areas. Remove and replace all structurally damaged wood materials by wood-destroying fungal rot and excessive moisture. All structurally damaged materials shall be replaced/repaired to a condition equal to adjacent areas where no damage exists. **All damaged wood must be removed.** All new materials shall be of a superior grade. Recommend determining the original cause of the problem and correcting/repairing as needed. Recommend using ground-contact pressure treated lumber, where applicable.

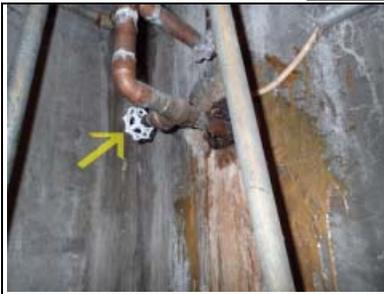
Water Main Shut-off Valve is located in the laundry room. Valve appears to be Operational (but not tested, testing may cause it to leak).  
Difficult to access at this time.  
Additional shut-off on the wall, above the dryer.

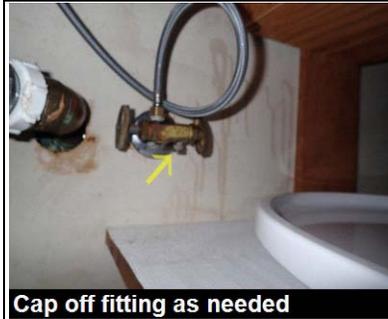
Conditions noted: Overall condition- Appears serviceable, with no visible concerns noted. No evidence of active/current leaks detected or significant problems/concerns noted at the time of the inspection. With the notable concerns/issues/exception;  
- Minor leak detected at the fitting under the kitchen sink. Add cap as needed.

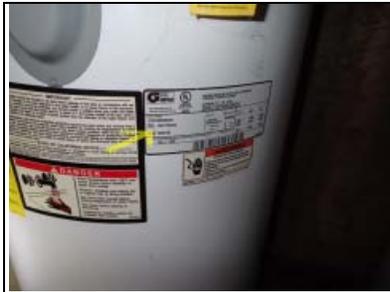
Estimated Age: Years: 9 (2007). Water heater is approaching the end of it's useful life (average life expectancy is approx. 10-12 years). Recommend replacing in the near future. Recommend installing the new water heater with all updated requirements (as they apply); recommend installed with proper/improved earthquake strapping, expansion tank and in a pan, on a foam pad or platform where applicable, for safety.

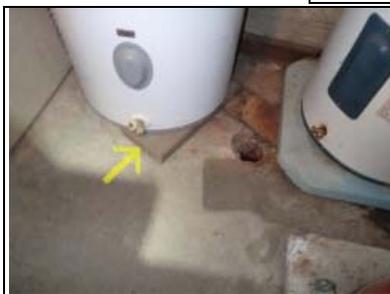
General Information: Water heater was installed on wood planks instead of a conventional foam pad.

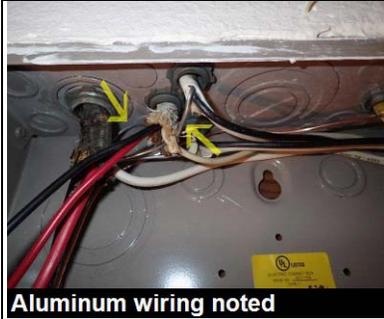
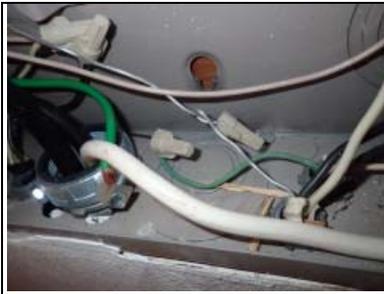
Panel Appears Serviceable- No significant problems noted at time of the inspection. With the notable exceptions/issues or concerns;  
 - **Aluminum branch wiring (#10 and/or #12) noted at circuit breakers and/or neutral and ground bus.** This appears to be the wall heater circuits. Recommend that all aluminum wiring be checked by a qualified, licensed electrical contractor familiar with aluminum wiring installations and practices. Recommend further evaluation of all the connections made in the panel box. Recommend adding anti-oxidant paste to the wire connections and breakers, using the appropriate pressure when re-installing these wires. Recommend checking all wiring connections in the house (electric wall heaters) as well, and use the proper and approved connectors (COPALUM or UL-approved equivalent).

Aluminum wiring noted

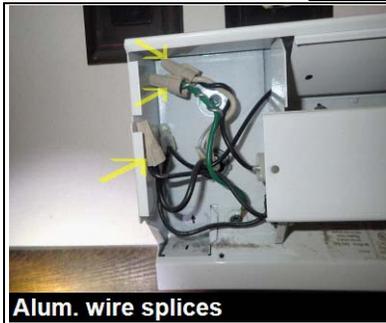
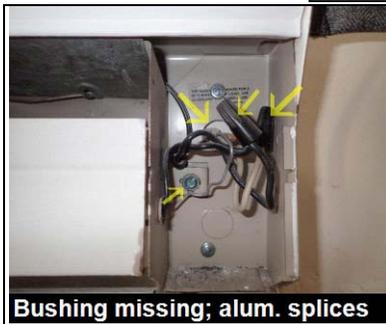
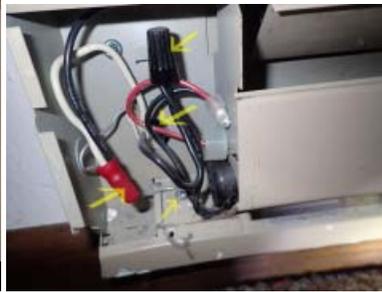
- Bushings are missing where the wiring enters the back of the baseboard heaters, located in the second bedroom and living room heaters, possibly more. Check wiring installation and correct as needed.

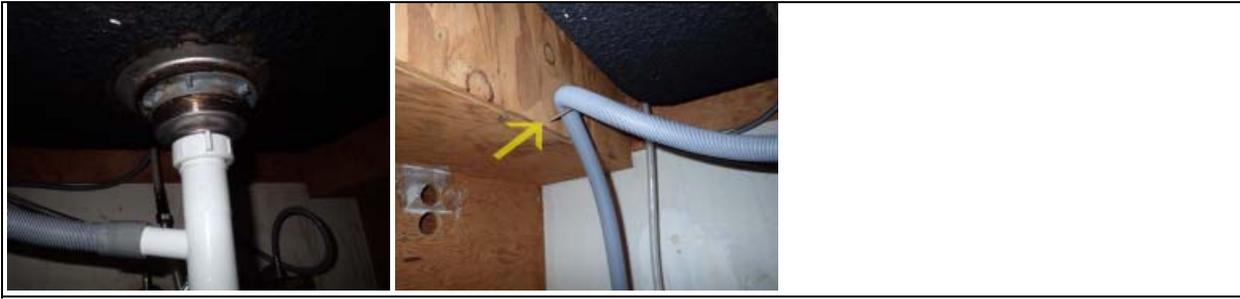
Condition:	Appears serviceable. Dishwasher was operated during the inspection and appears to be functional/operational. An air gap is not provided in the dishwasher drain line. A high loop was installed in the drain line, located under the sink, to prevent drainage back into the appliance (accepted practice by current standards) Recommend supporting the drain hose using the proper strapping, and clamp the hose to the sink drain fitting to prevent leaks also.
------------	---

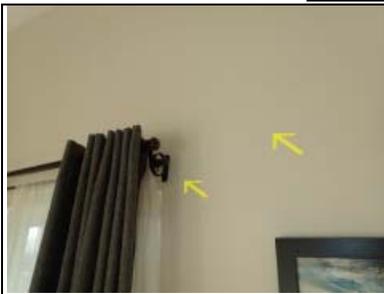
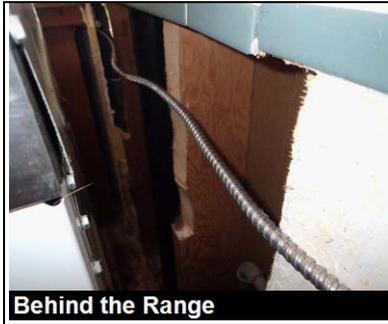
Overall condition- Appears serviceable, with no significant defects or concerns visible at this time. With the exceptions/concerns/issues noted;  
 - Diagonal cracking in the wallboard over the living room slider.  
 - Wallboard is missing in the kitchen (behind the Range). Recommend replacing the wallboard to reduce heat loss, air movement and a connection to the Units below.  
 - Opening in the front entry closet wall; old opening in the siding noted. Possible past animal entry point?

Behind the Range

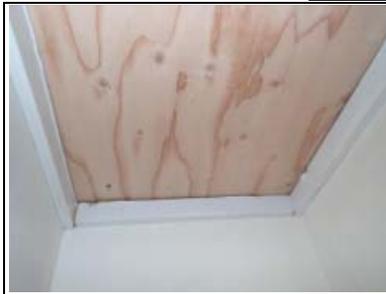
- Opening and framing limit access to the space.
- The weather-strip is missing along the scuttle access opening- recommend installing to prevent heat loss into the attic. And insulate cover as needed.

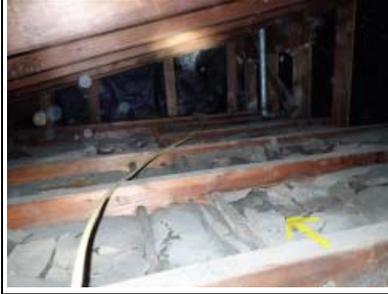
Overall Condition- Appears serviceable, the insulation appears to be providing adequate and uniform coverage at this time.  
 Recommend adding/improving the insulation in the attic area, to cover all areas and to increase energy efficiency. Recommend adding insulation to provide proper coverage throughout the attic space. Current building standards is R-49 value.

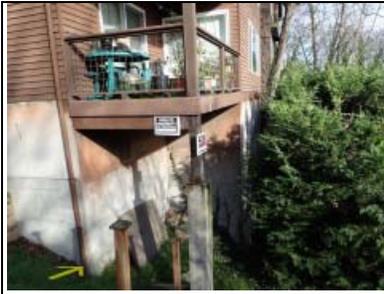
The north gutter drain leaks into the sanitary sewer system. Recommend confirming with the City to determine if discharging into the sanitary sewer system is permitted.  
The south drain line discharges under the lower deck area (galvanized pipe drain under the soils). Recommend installing a plastic drain line underground and discharge away from the deck footing base.

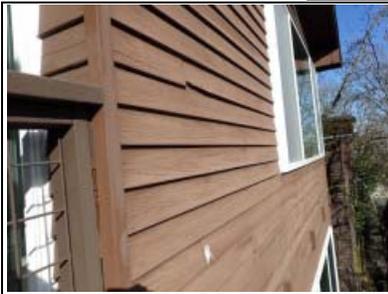
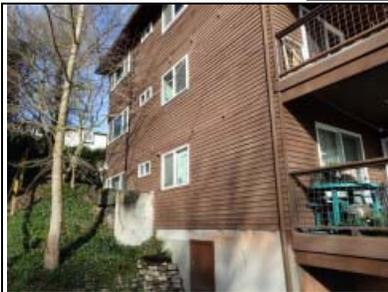
Overall Condition of the siding materials- Appears Serviceable, and the exterior cladding appears to be performing as intended. With the notable concerns/issues/exception;  
 - Deterioration/damage noted in the siding/cladding materials; wear/tear on the east and south sides of the house. Recommend replacing the damaged boards as needed.  
 Siding/cladding appears to be in need of painting, caulking and/or maintenance. Old and worn paint on the exterior siding/cladding, which may lead to damage to the siding material.  
 Recommend painting the house in the near future. Caulk and seal all nails holes and joints as needed to prevent water intrusion.

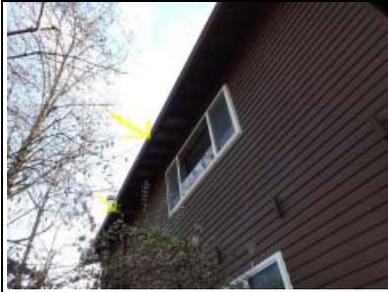
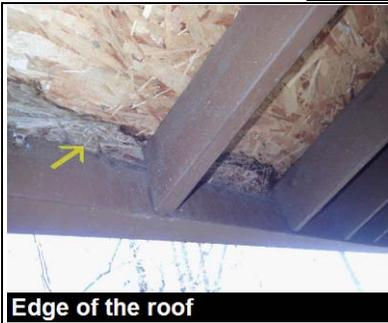
Overall condition- Appears Serviceable.  
- Staining and minor fungal rot damage in the north eaves; keep gutters clear of debris build-up. Recommend painting the open eaves as needed.

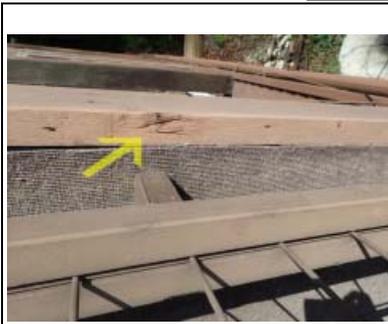
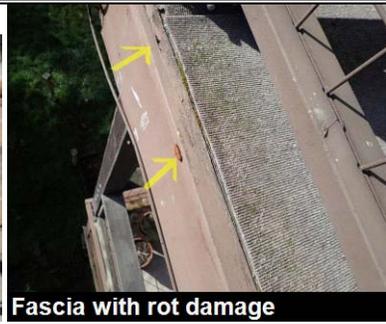
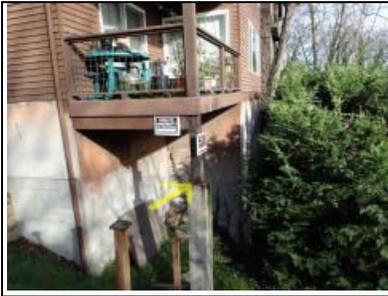
General Condition of the deck structure- Appears Serviceable. Guard rail- Appears Serviceable at this time.  
- Fungal rot in the fascia boards (east and south sides). Recommend replacing damaged boards as needed.  
- Watch for rot damage to the 6x post at the base of the stacked decks.

Evidence of fungal rot decay/damage to structural components of the exterior deck structure, located at/in (but not limited to): on the fascia boards. Replace damaged wood as needed.

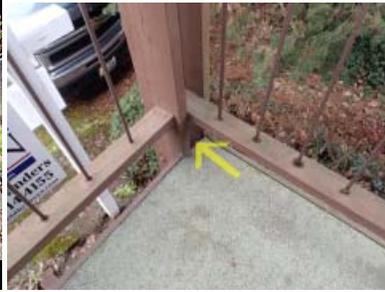
**Damage to the outer post**

Conditions: Overall condition- Appears Serviceable *at this time*, but with fungal rot damage to multiple locations in the steps, railing and outer structural posts. Probable need for replacement of these components in the very near future. Recommend contacting a licensed contractor to evaluate the porch and correct/repair as needed.

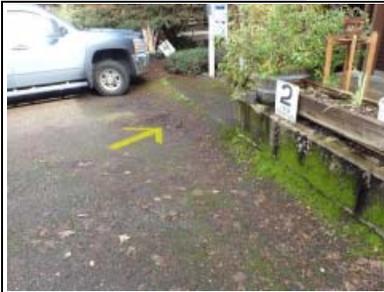
Overall condition- Appears serviceable; appears to be functioning as intended. Degradation to the driving surface- primarily due to age/type of materials.  
Drainage appears to be ponding near the sidewalk opening.

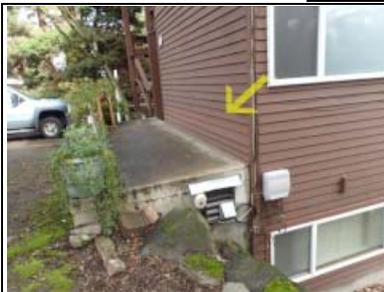
Overall condition- Appears serviceable.  
- Walk-off hazard at the south edge of the walkway. Recommend installing a guard rail as needed.

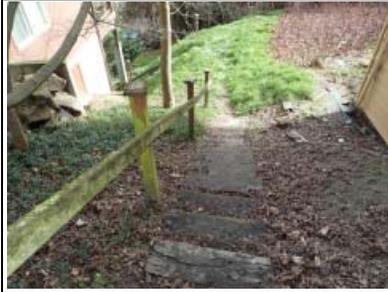
The wood steps to the crawl space are deteriorating; fungal rot/insect damage to several of the steps; steps are sloped improperly and slick. Handrail is marginal also. Recommend re-building the steps using masonry materials.

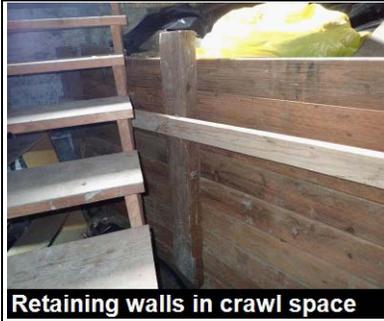
Retaining walls in crawl space
