# Confidential Home Inspection Report

Prepared for: **Prudent Home Buyer**

Any Street  
Kirkland, WA 98000

November 2, 2016

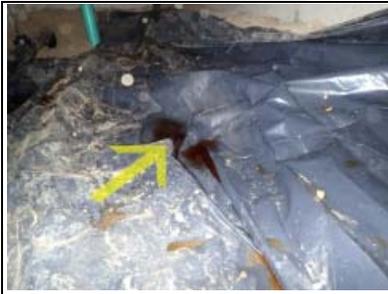
Accessibility into Sub-Area:	Sub-structure crawl space is reasonably accessible- clearances are ample/adequate at this time, in most areas. Entered the sub-area for a full inspection.
Floor Type:	Dirt/Silt-type soils.
Dampness/Moisture:	Normal/typical dampness and/or moisture noted during the inspection- no significant moisture noted during the inspection process. - Traces of water on the plastic, located under the front entry.

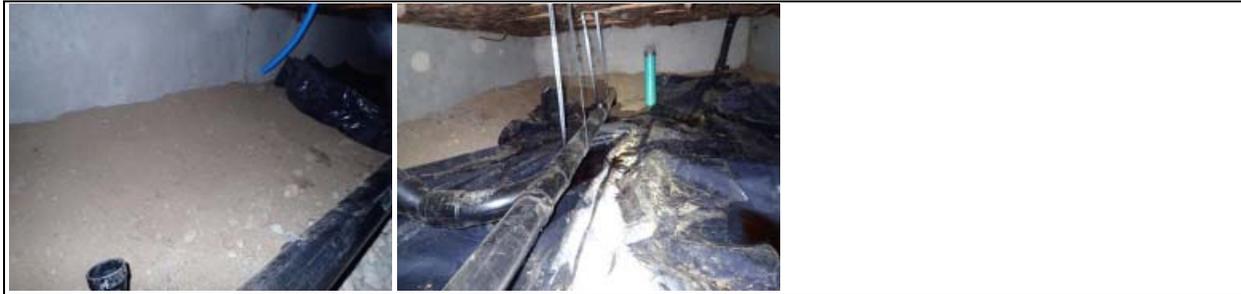
The vapor barrier is missing in portions of the sub-area; exposed/open soils noted in the crawl space. Recommend respreading the plastic to cover all the soils in the crawl space, or add more plastic as needed. Overlap ends at least 12" and secure with bricks/stones or metal fasteners, as needed.

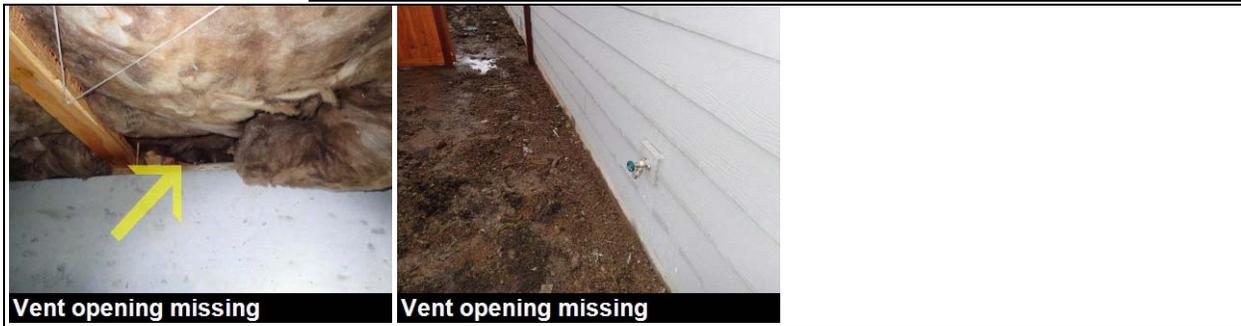
Ventilation appears to be adequate/sufficient at this time. The quantity and location of the foundation vents appear to provide adequate air flow in the crawl space sub-area. With the notable exceptions/concerns/issues;  
- Vent opening is missing on the SE corner of the house; opening cut through the rim joist, but sided over.

Vent opening missing

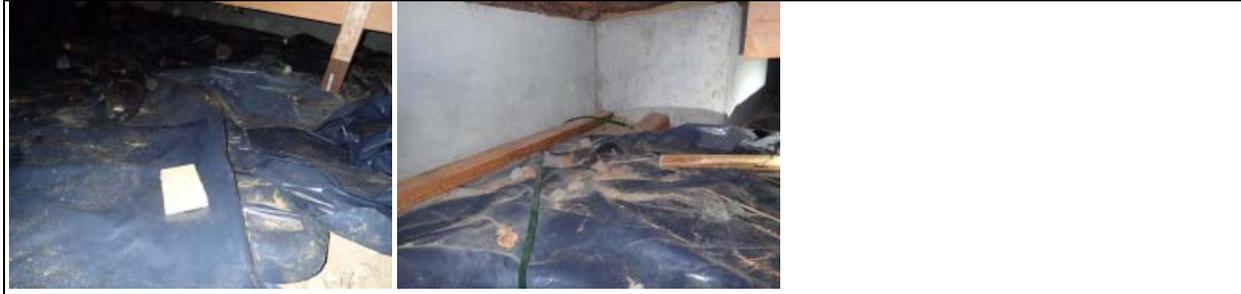
Construction/wood/cellulose debris noted in the crawl space area. Recommend removing all wood/cellulose debris, that can be raked or larger, and discard from the crawl space area.

Construction and cellulose/wood debris should always be removed from the sub-area (as required); the presence of cellulose/wood materials is conducive to wood-destroying fungal rot and insect infestations, which may lead to other issues. Cardboard forms, often found around newer concrete footing pads, should be removed where needed (not as critical as wood forms). In some regions of the Puget Sound area, these cardboard forms are prone to subterranean termite infestations, which may lead to infestation in the wood framing also.

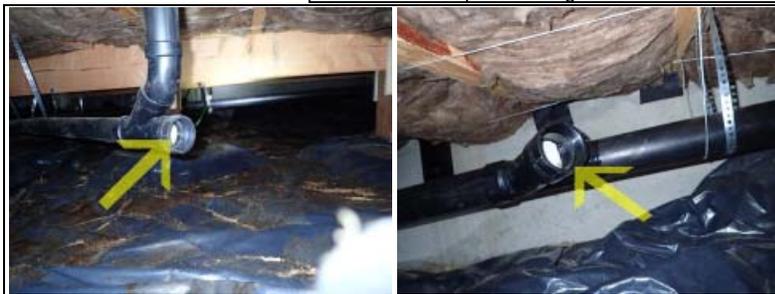
**Conditions noted:** Overall condition- Appears serviceable. No visible problems detected at this time. No evidence of significant leaks detected or concerns/problems noted at time of the inspection.  
 - Clean-out caps missing on two of the clean-out fittings in the crawl space.

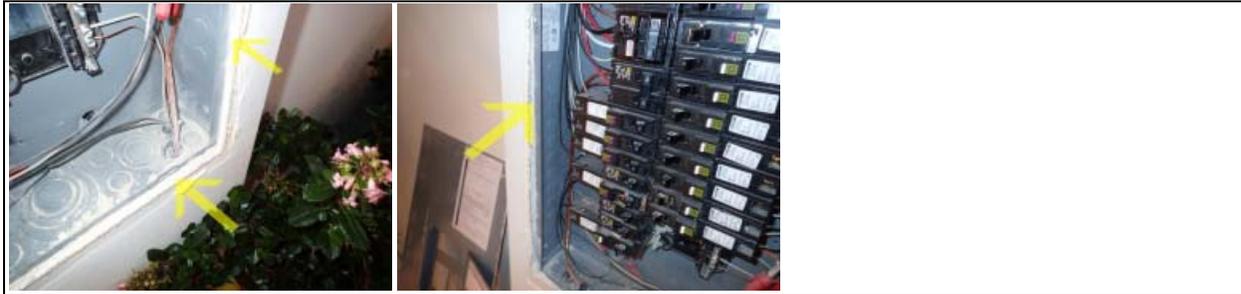
Panel Appears Serviceable- No significant problems noted at time of the inspection.  
- Panel box is not flush-mounted to the garage wallboard as required. Recommend resetting the panel box flush to the garage wall.

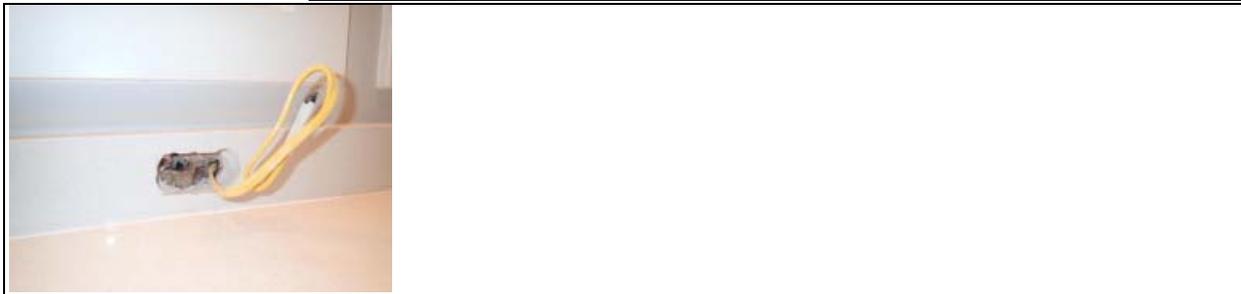
Overall wiring practices appear to be serviceable/operational. With the notable exceptions/concern/Issues:  
- Open wiring/outlet not installed in the master bathroom.

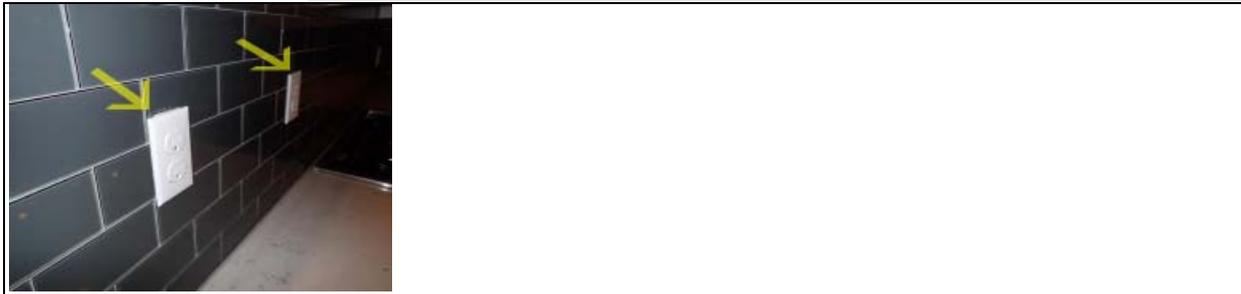
A representative sampling of switches and receptacles/outlets were tested. As a whole, receptacles/outlets and switches throughout the house, appear to be in serviceable condition. Fixtures appear to be in overall serviceable condition. With the noted exception/concern/issues:  
- Gaps at the cover plates and backsplash tiles in the kitchen.

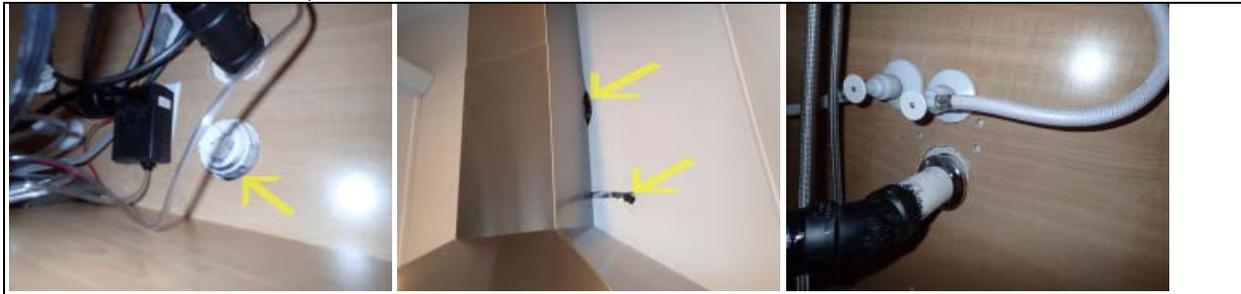
Conditions: Overall condition- Appears serviceable, with no significant defects or concerns visible at this time. With the exceptions/concerns/issues noted:  
 - Openings in the wallboard- located under the sinks (escutcheon plates are not tight at the drain-waste pipes) Recommend sealing off all wall openings to keep the fire-stops intact, prevent heat loss and air movement through the walls.  
 - Opening in the wallboard, located at the kitchen exhaust vent hood.  
 - Recent repairs in the lower bedroom wall (around the door opening)  
 - Upper front bedroom walls (ceiling) are unfinished- recent repairs/corrections to the trusses and stud framing.  
 - Opening in the wallboard, located in the master bathroom ( next to the outlet)  
 - Damage in the master closet walls.

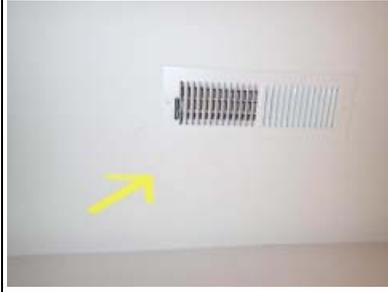
Overall condition- Appears serviceable, with no significant defects or concerns visible at this time.  
- Overdriven nails in the kitchen ceiling at the heat register.  
- Unfinished ceiling in the front, upper bedroom; recent repairs/correction of the roof truss framing.  
- Unfinished ceiling in the master bedroom ceiling also.

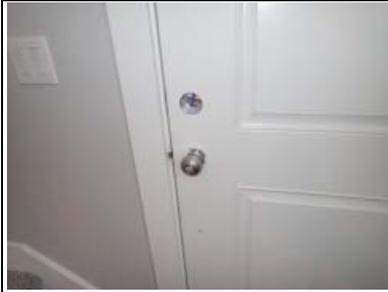
Fiberglass/Composite, Overall condition- Appears serviceable and operating properly. Weatherstripping around door appears serviceable.  
- Hardware and weatherstripping are missing/incomplete.

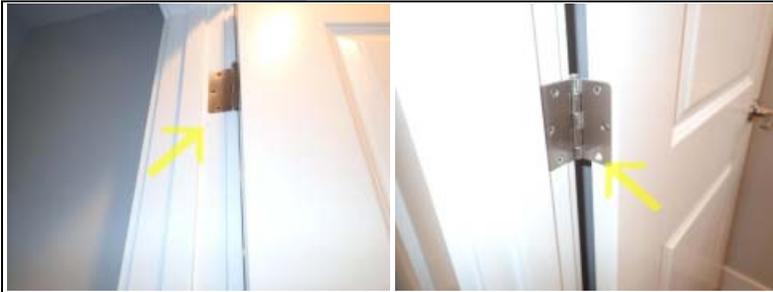
Overall condition- Appears serviceable/operational. With the exception/concerns/issues noted;  
- Pantry and guest bedroom doors with nail heads pushing through the side jamb?  
- Master bedroom closet door binding at the stop.  
- Water closet door missing a screw fastener in the hinge.  
- Loose hinge (upper) in the lower bathroom door.

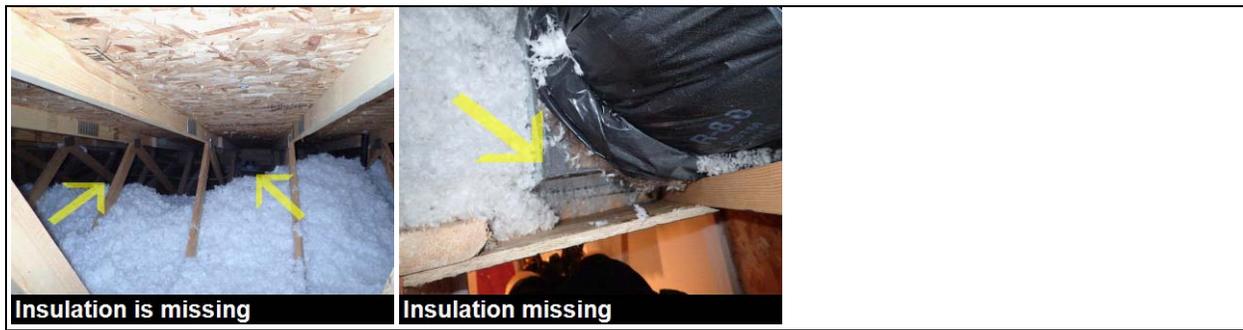
Type(s):	Fiberglass- Blown-in/loose.
Approx. Depth and R-value:	18+ inches, R-49 value (current building standard for ceilings)
Conditions:	Overall Condition- Appears serviceable, the insulation appears to be providing adequate and uniform coverage at this time. With the notable concerns/issues; - Insulation is missing over the front bedroom due to recent alterations to the roof framing in this area; compressed insulation from the scuttle access noted also. - Missing insulation around the scuttle access well. Recommend adding additional insulation to restore the insulation to it's original R-factor (R-49)

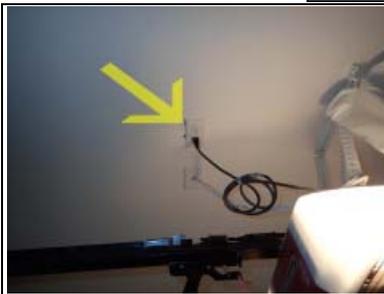
Conditions: Overall condition of the firewall- Appears serviceable, and appears to be providing adequate separate between the garage and house.  
- Seal opening in the ceiling around the outlet.

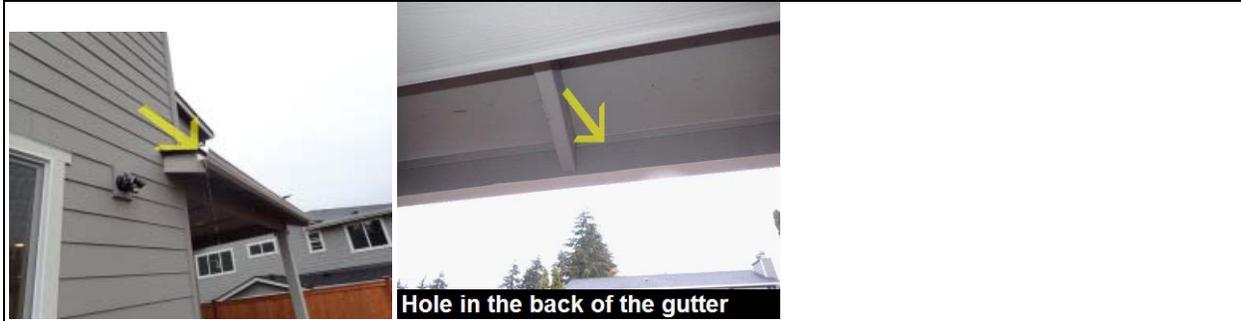
- Hole in the lower gutter, located over the patio
- Upper, south gutter (off the master bedroom/bath), is not fully attached to the rafter tails.
- Open-ended gutters on the front porch and back patio roof- system is not complete at this time.

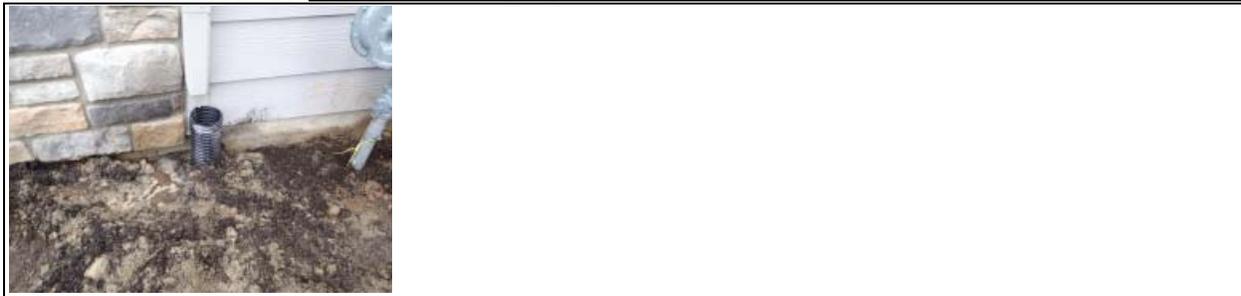
Incomplete drainage system at this time.

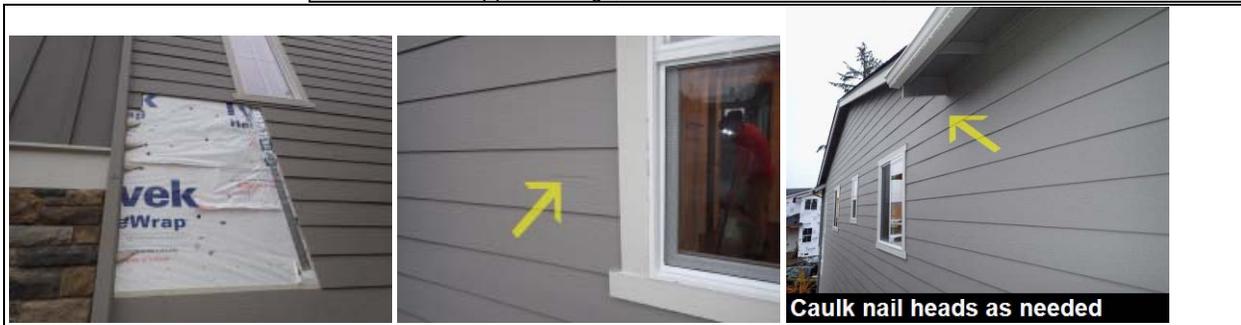
Materials Used:	Fiber-cement materials (lapped, panels and/or shingles)- Hardiplank products. Cultured Stone Veneer.
Conditions Observed:	Overall Condition of the siding materials- Appears Serviceable, and the exterior cladding appears to be performing as intended. - Opening in the lapped siding, located on the front corner (NE) of the house (being repaired at the time of the Inspection) - Overdriven nail heads in the lapped siding, located on the north side- upper courses. - Notch in the lapped siding (from a circular saw blade) on the north side also.

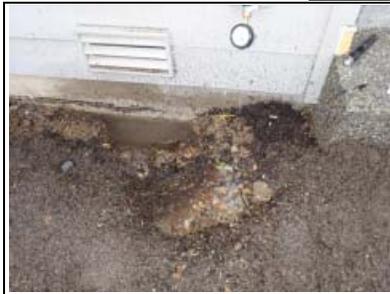
The site is relatively flat or has a positive slope (away from the house) around most of the foundation/housewall. Overall condition- Appears Serviceable. No apparent significant drainage problems noted at the housewall at this time. With the issues/concerns noted;  
- The gutter system is incomplete and draining water next to the foundation wall and siding.
