# Confidential Home Inspection Report

Prepared for: **Mr. House Hunter**

Any Street  
Lynnwood, WA 98000

March 3, 2016

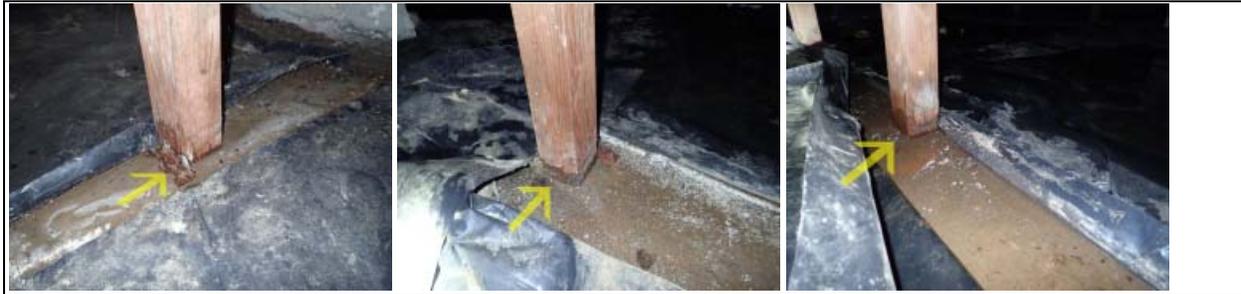
Conditions: Concerns/issues noted at the time of the inspection;  
 - Several of the structural posts are in standing water in the crawl space at this time, or have been wet recently. Despite being pressure-treated wood, the wood posts are prone to fungal rot damage overtime. The metal brackets attached to the posts are rusted/corroded and may not restrain the posts anymore.  
 Recommend further evaluation of all the posts in the sub-structure framing after the water is removed, to determine if replacement is needed for the posts. Possible need to add raised footings and replace the posts, to allow for the proper clearance above the soils grade level. Recommend contacting a qualified, licensed contractor to make further evaluations and make all necessary repairs/corrections as needed.

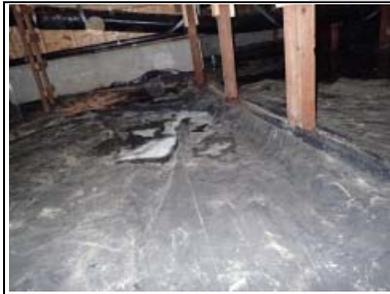
Photo:

The vapor barrier appears to be in poor condition: Plastic is covered with, mud/silt from past flooding, fallen/damaged fiberglass insulation. Recommend complete removal of the old plastic vapor barrier(s) in the crawl space sub-area, prior to installing the new materials. Recommend installing new **6 mil., black polyethylene plastic sheeting** to cover all soils in the crawl space. Overlap plastic at least 12" at all joints; do not run plastic up the base of the wood posts or framing, and secure the plastic with stones/bricks or fasteners to prevent movement.

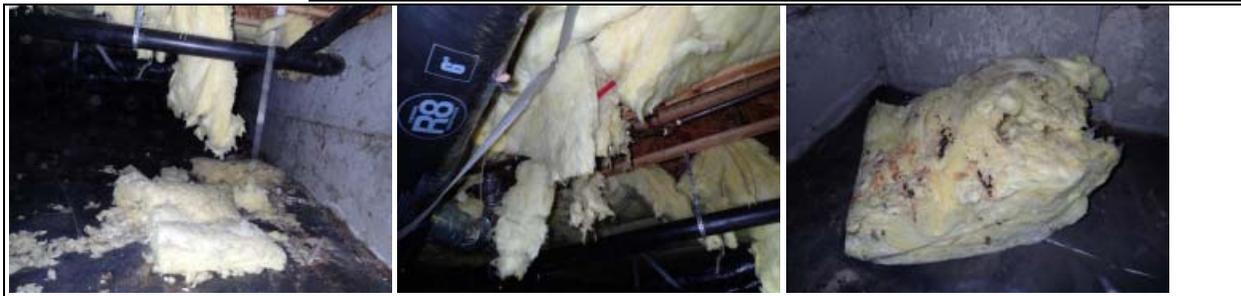
Fiberglass; Estimated R-factor: 19 (+/-). Evidence of rodent nesting and/or damage to the sub-floor insulation; urine staining, droppings and debris noted on/in the sub-floor insulation. Recommend removing and replacing all the damaged and infested sub-floor insulation in the crawl space sub-area as needed. All infested insulation should be removed. Recommend replacing insulation with similar R-value or improve as needed. Recommend contacting a qualified, licensed insulation specialist about the replacement of the sub-floor insulation.

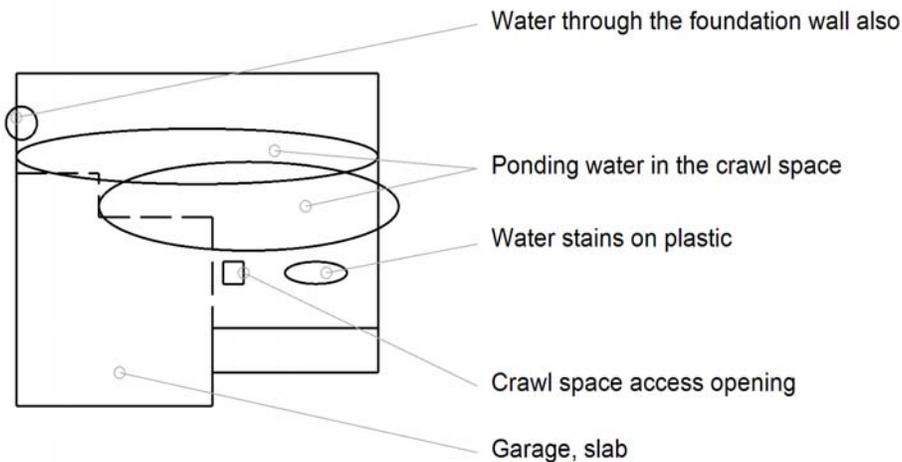
Crawl Space Conditions:

High moisture conditions observed during inspection- potential for wood-decay rot, molds/mildew and rodent and insect infestation.  
Posts are at/below grade level and are sitting in the water through the middle of the house.

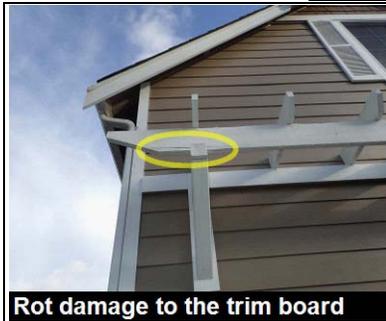
Findings/Location(s)- Exterior Roof Eaves/Trim:	Evidence of fungal rot decay/damage to the trim, located (but not limited to): at the trellis on the front of the house. Replace damaged wood as needed.
--	--

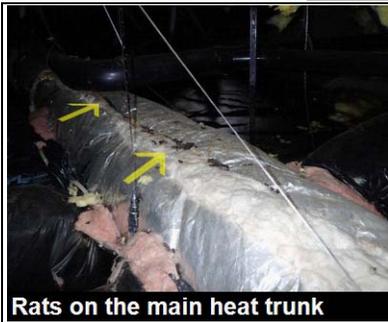
Type of Infestation(s) noted:	Rats.
Evidence of Infestation:	Rodent droppings noted, on the plastic vapor barrier, on/in the sub-floor insulation batts, on the heat ducting/insulation, throughout the crawl space sub-area. Insulation has been effected/damaged: sub-floor insulation has been pulled-down and/or damaged in the crawl space sub-area, staining from rodent droppings/urine Unable to determine if this infestation/problem is active or inactive- a specialist is needed to determine activity status.
Recommendations:	Recommend locating all the sources of the rodent/vermin entry into the house; (attic, garage and/or sub-area) and correct and seal off as needed, using approved methods and materials. Recommend contacting a licensed specialist in rodent clean-up and remediations. Make all necessary corrections/repairs to prevent further infestation and clean/sanitize the area(s) of infestation for health reasons. Recommend contacting a licensed, professional and certified pest management company (PCO) to prevent or remedy the pest activity/damage.

Rats on the main heat trunk

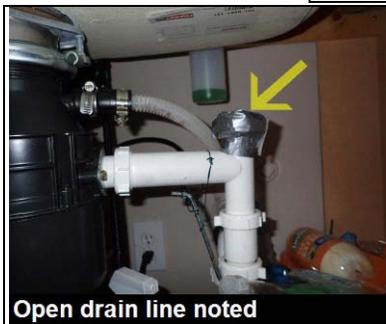
- Open drain-waste pipe located under the kitchen sink (drain system was modified with the replacement of the sink). Recommend replacing with the proper drain pipes/fitting. Recommend contacting a qualified, licensed plumbing contractor for evaluation and repair/correct as needed.

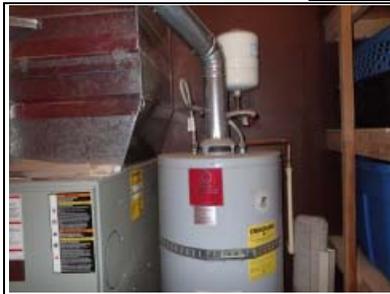
Location:	Garage.
Type and Size:	Gas appliance, 50 Gallons.
Estimated Age:	Original equipment. Years: 10+ (Manufactured in 2005). Water heater is approaching the end of it's useful life (average life expectancy is approx. 10-12 years). Recommend replacing in the near future. Recommend installing the new water heater with all updated requirements (as they apply); recommend installed with proper/improved earthquake strapping, expansion tank and in a pan, on a foam pad or platform where applicable, for safety.
Gas Pipe/Valve:	Valve is located next to the water heater; Appears Serviceable.
Water Heater Installation:	Overall condition- Appears serviceable; with no visible issues noted at this time. - Temperature & Pressure relief valve (T&P or TPR)- appears to be installed properly in the tank. (Note: This is not tested for operation). The overflow discharge pipe, on the T&P valve, appears to be installed properly. This overflow pipe/tube is designed to drain the hot water out of the tank and prevent the tank from bursting. The overflow discharge pipe terminates, to the exterior of the house (visible). - Exhaust vent appears serviceable, no visible issues noted. - Earthquake/seismic strapping appears to be, adequate/serviceable. - An Expansion tank, has been installed and appears serviceable at this time.

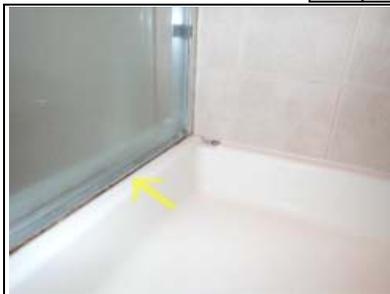
Location:	Master Bedroom.
Type:	Full- Tub surround and Shower surround.
Tub/Shower Enclosure:	Tile- Ceramic/Porcelain/Stone, with Plastic pan.
Enclosure Conditions:	Overall condition of the shower enclosure appears serviceable. - Recommend sealing (clean as needed) the grout lines in the surround to protect against water penetration. - Replace caulking at the door frame as needed.

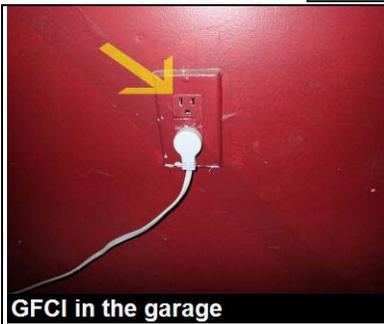
The installed Ground Fault Circuit Interrupter(s) appears to be serviceable/operational when tested. With the notable exception/concern/issues;  
- The garage GFCI was painted and may not trip off as intended. Recommend replacing the GFCI for safety reasons.

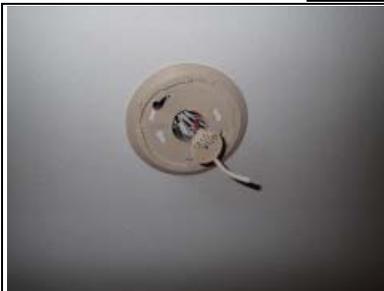
Appear to be operational/functional (but were not tested at this time)- All areas where detectors are installed, *with the exception noted*;  
- Detector is missing in the middle bedroom. Replace as needed, for safety reasons.

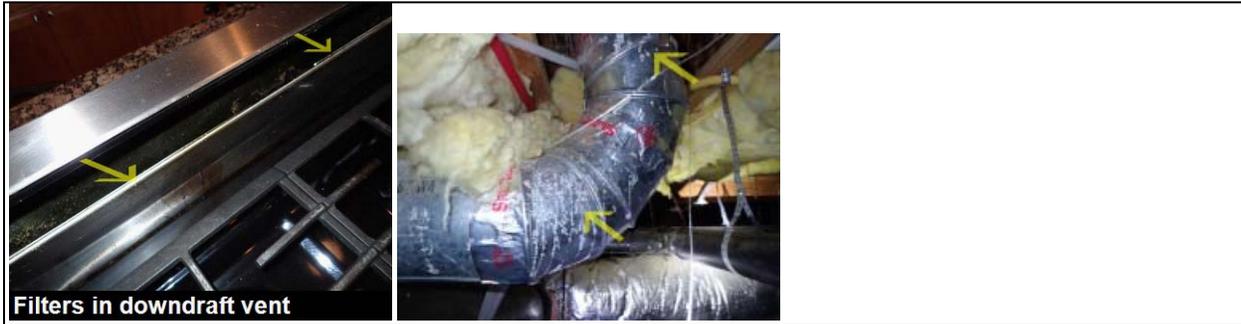
Exhaust Hood/Fan system- Appears operational/functional and appears to be operating as intended. Appears to be venting out of the kitchen area.  
- Exhaust fan/filter system is dirty and needs cleaning for efficiency.  
- Rust/corrosion on the metal duct in the crawl space. This duct was not insulated. Recommend adding insulation to reduce condensation issue.

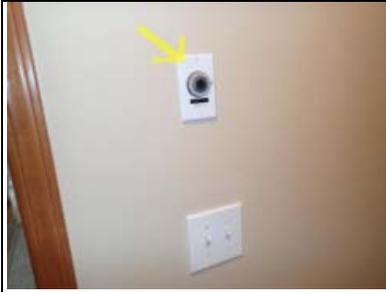
Condition:	The ventilation system appears serviceable/operational and is functioning as designed/intended, but the window ventilators were not installed in all the bedrooms, as designed. The first and third smaller bedrooms do not have window ventilators; the family room has ventilators in both windows instead. The system will not function as intended.
------------	--

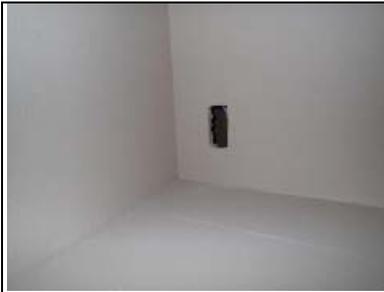
Type(s):	Drywall/Gypsum wallboard.
Conditions:	Overall condition- Appears serviceable, with no significant defects or concerns visible at this time. - Small holes in the wallboard, located on both sides of the fireplace. Recommend sealing off all wall openings to keep the fire-stops intact, prevent heat loss and air movement through the walls.

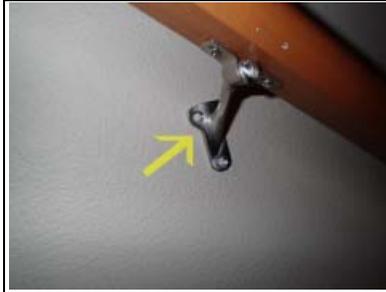
Interior stairs- Appear serviceable. Stair handrail appears serviceable, but is not fastened to the wall/framing sufficiently. Check brackets and fasten to the stud framing as needed.  
Guard rail, around the stairwell, appears serviceable. Balusters are loose, but functional.

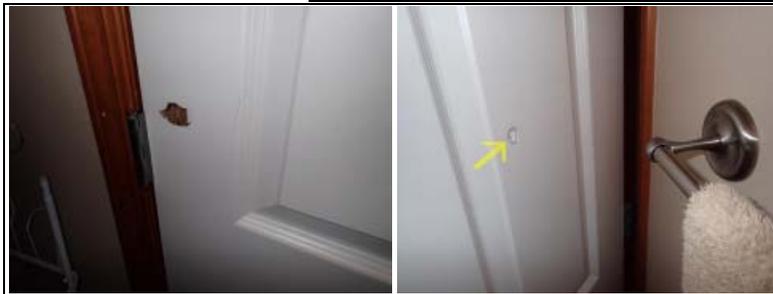
Overall condition- Appears serviceable/operational. With the exception/concerns/issues noted;  
- Minor damage behind the master bath and master closet doors. Add door stops as needed.  
- Door stops are missing the rubber bumpers also- replace as needed.

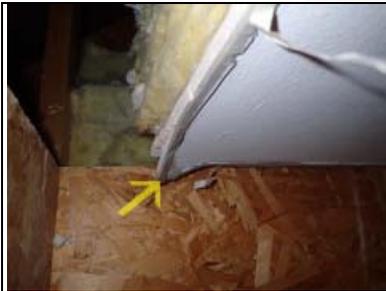
Scuttlehole opening (in ceiling). Entered this area for a visual inspection.  
Viewed the garage attic from the openings.  
- Access scuttle is partially damaged in the master bedroom closet- drywall is cracked or broken.  
Watch for heat loss in this area.

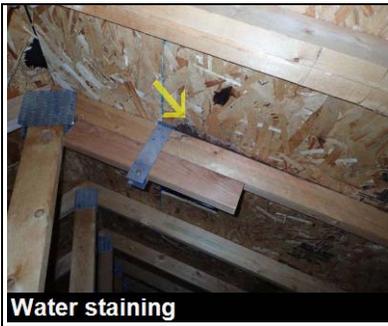
No significant structural issues/problems noted at the time of the inspection. Water staining noted in the attic space during the inspection- appears to be inactive, old and/or dry at the time of the inspection.  
Water staining at the fall arrest roof anchor bracket- the cap was re-installed during the inspection, which should stop the leaks from re-occurring.

Water staining

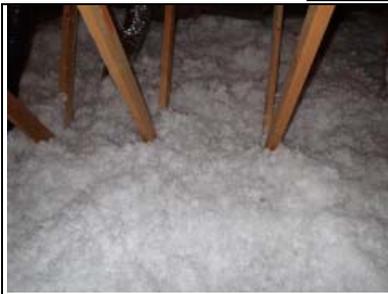
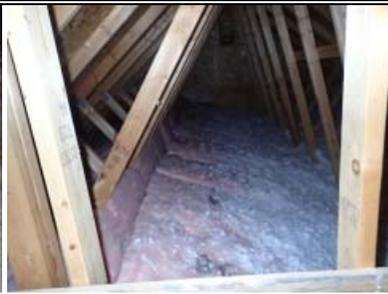
Overall Condition- Appears serviceable, the insulation appears to be providing adequate and uniform coverage at this time.  
 - Insulation was partially disturbed over the bathroom area- the exhaust vent was re-connected.

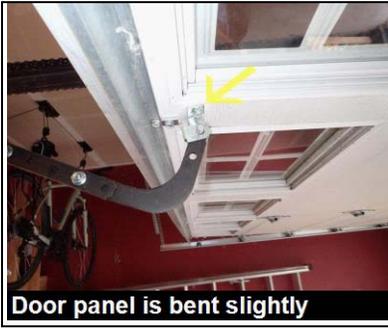
Condition(s): Overall condition- Appears serviceable and functions as intended. With the concerns/issues noted;  
- Slight bent at the upper bracket. Possible need for reinforcement of this bracket and door connection. Recommend contacting a qualified/trained door system technician for further evaluations and make all corrections/repairs to the garage door as needed, for safety.

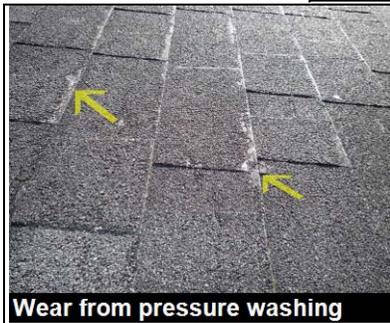
Style:	Gable roof- Triangular end portion of a building from the eaves to the ridge of the roof.
Primary Materials:	Asphalt/fiberglass composition shingles; made with fiberglass/organic felt base that is impregnated with asphalt and covered on the surface with granulated stone (which protects against UV damage and provides the color). Architectural grade; multiple-layer laminated construction shingles. Heavyweight shingles with an average life-span of 25-50 years (depending on the type and thickness).
Accessibility:	Walked on the roof.
Specific conditions of roofing materials;	Asphalt shingles with the following conditions visible: - Evidence of prior pressure washing noted on the roofing materials; surface granules are loose/missing/worn-off. Minor wear and damage to the front porch roof.

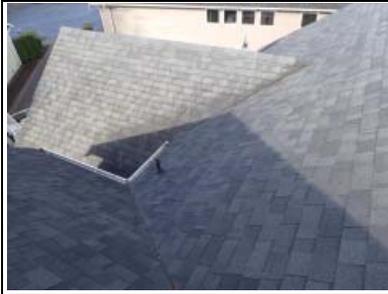
General condition- Appears Serviceable; conditions are based on the age/type and the typical wear of the roofing material. No significant problems or issues noted at the time of the inspection.  
Build-up and debris noted on roofing material; Moss/fungus (green mass build-up/staining). Recommend cleaning off the excessive debris from the roofing materials, to prevent premature wear and tear. Recommend cleaning off and treating the roof with an approved fungicide, or moss inhibitor, to prevent further growth of the moss.

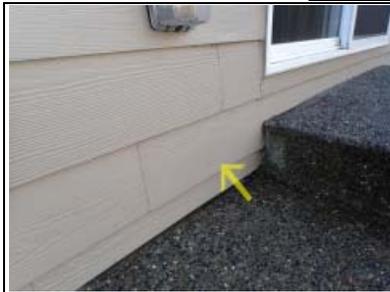
Overall Condition of the siding materials- Appears Serviceable, and the exterior cladding appears to be performing as intended.  
 - Prior repairs to the lapped siding at the back steps- gas pipe was passing through the wall at this location.

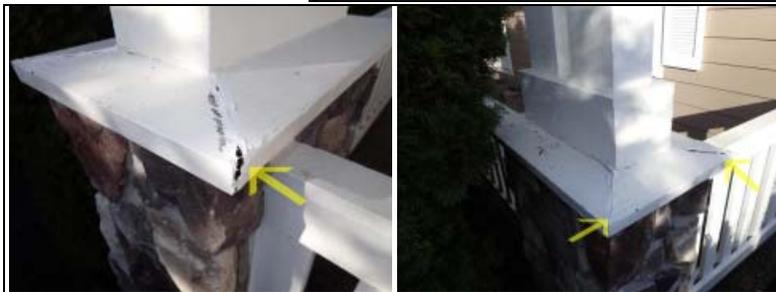
Overall condition- Appears Serviceable. With the notable concerns/issues/exception;  
 - The front column trim boards are separating at the joints and will be prone to water intrusion and moisture-related damage. Recommend re-installing the boards tight and caulk/seal the joints and re-paint as needed.
