Confidential Home Inspection Report

Older Neighborhood

September 26, 2016

Seaview Home Inspections, LLC

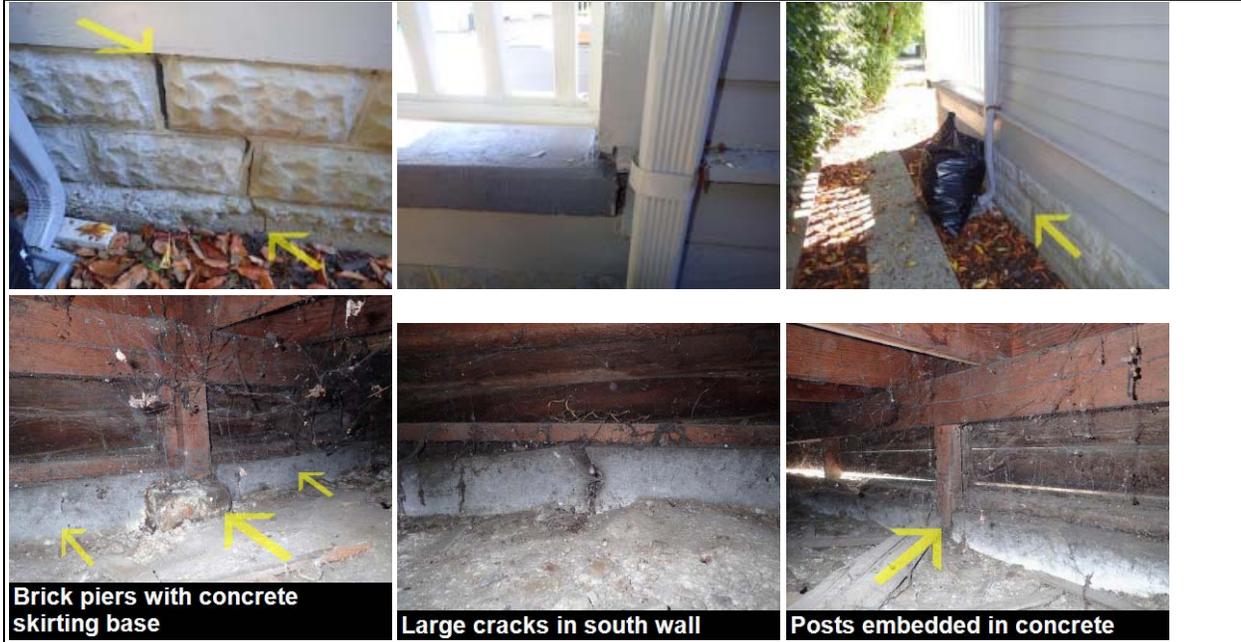
- Step cracking on the foundation wall, located on the north and south sides of the house, at the house to porch transition. Evidence of the porch landing separating from the house wall also. (Note: The foundation walls/footings around the perimeter of the crawl space are probably considerably smaller than the basement walls. Further evaluations would be needed to determine how deep the foundation wall/footings are, and what type of condition they are in- soils are covering the concrete in the crawl space.

between the brick pier footings and wood posts, and seal-off the skirting base, and the concrete does not provide any structural support. Large cracks and movement in section of the small concrete walls and 2x skirting posts.

Recommend consulting a qualified, licensed contractor specializing in foundation repairs for further evaluations of the conditions noted during the inspection, and determine what repairs/corrections are needed to help stabilize the house and sub-structure framing.

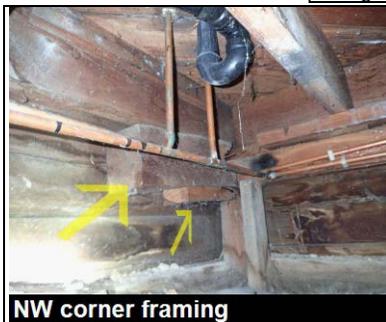
Type/Size:	Solid/Built-up: 6x6's or larger.
Conditions:	Overall condition- Appears serviceable. With the notable exceptions/concerns/issues; - The sub-floor framing under the lower bathroom with fungal rot and insect damage to the perimeter framing; the NW corner of the house with questionable framing installation. Recommend improving the sub-floor framing as needed with the repairs under the bathroom and along the north wall.

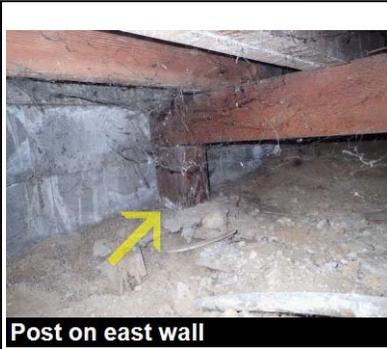
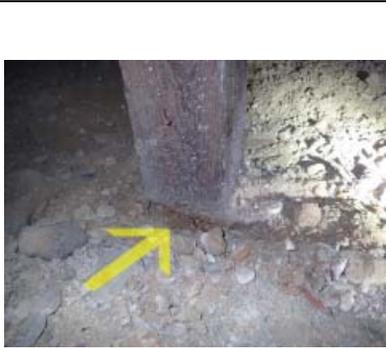
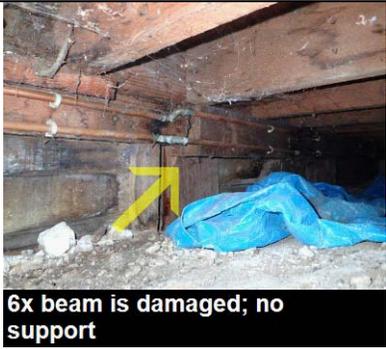
Conditions: Appear serviceable- Overall condition. With the notable concerns/issues/exception:
- The 6x6 posts in the basement are damaged at the base. Replace posts as needed. See WDO section of the report, for additional information of the conditions noted.

- Soils contact to some wood posts/wood blocks, minimal clearance or posts are near soils grade level. Clear the soils away from all wood posts and blocks as needed. Watch for rot/insect damage to the posts in the crawl space area. Replace all damaged materials as needed, using pressure- treated lumber.

- The 6x post appears to be missing, located under the north wall where the lower bathroom is installed. The fungal rot damaged 6x beam is suspended in air, with no apparent post support noted. Recommend adding a 6x post after all the repairs are made to the sub-framing under the bathroom and stair covering
Recommend replacing the post(s) with the proper type/size structural lumber. Recommend using pressure-treated posts where needed. Recommend contacting a qualified, licensed contractor to make further evaluations and make all necessary repairs/corrections as needed.

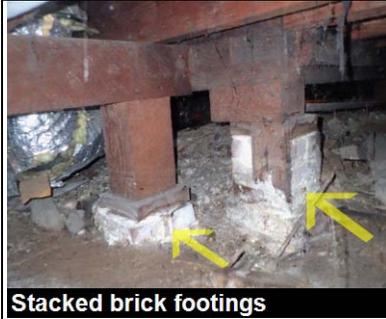
Concerns/problems noted with the footings used at the time of the inspection:
 - Bricks are considered non-conventional* footings materials (used as piers/footings under all the posts in the crawl space area and some of the perimeter framing) and do not provide adequate load-bearing support of the posts and beams. Recommend replacing these components as needed, using conventional footings rated for the proper load-bearing to support the exterior and interior sub-floor framing. Recommend contacting a qualified, licensed contractor to make further evaluations and make all necessary repairs/corrections as needed.

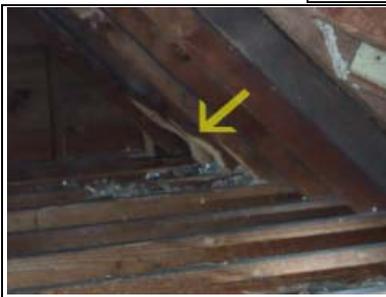
Overall Condition- Appears Serviceable. No visible defects or concerns noted at the time of the inspection. With the notable exceptions/concerns/issues:
 - Gnawing on some the 2x4 rafters is various areas of the attic space; rat and animal activity in the attic space. Repair damaged wood as needed.

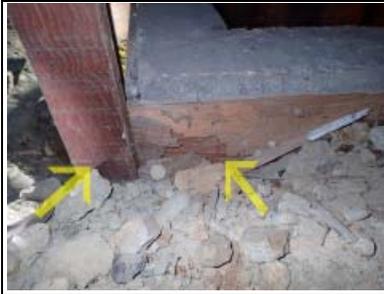
Construction/wood/cellulose debris noted in the crawl space area. Form boards still present on the back of the interior concrete walls of the basement; and 2x wood posts are touching soils in multiple areas.
- Recommend removing all wood/cellulose debris, that can be raked or larger, and discard from the crawl space area. Eliminate all wood-soil contact in the crawl space area and remove any non-load bearing wood members as needed. All structural wood members, embedded in concrete, should be replaced with pressure-treated lumber.

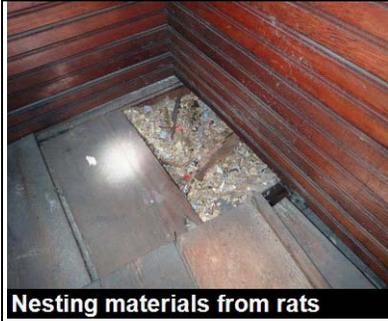
Type of Infestation(s) noted:	Rats. Raccoons?
Evidence of Infestation:	Rodent nesting materials in the side attic spaces, where the old chimney/fireplace is installed. Rodent droppings and animal feces noted in the attic space (odor detected in the upper attic space). Droppings in the basement and crawl space areas also Gnawing on the roof framing in the upper attic space and frayed wiring noted. Openings through the crawl space skirting and basement stairwell (wall framing). Bait containers noted during the inspection.

Conditions Observed:	The rodent infestation, located in the crawl space sub-area, appears to have been a long-term problem.
Recommendations:	Recommend locating all the sources of the rodent/vermin entry into the house; (attic, basement and sub-area) and correct and seal off as needed, using approved methods and materials. Recommend contacting a licensed specialist in rodent clean-up and remediations. Make all necessary corrections/repairs to prevent further infestation and clean/sanitize the area(s) of infestation for health reasons. Recommend contacting a licensed, professional and certified pest management company (PCO) to prevent or remedy the pest activity and/or damage as needed.

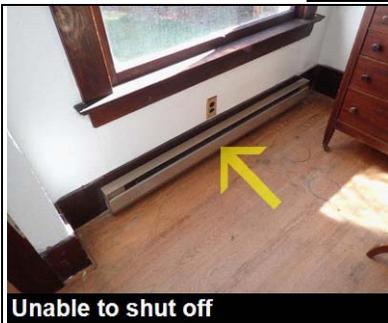
Additional Heating:	Back bedroom. Electric- Baseboard. The smaller heater is running continuously (<i>cannot shut-off with the thermostat</i>) and the larger wall heater is not functional at this time. Recommend correcting for safety reasons.
---------------------	--

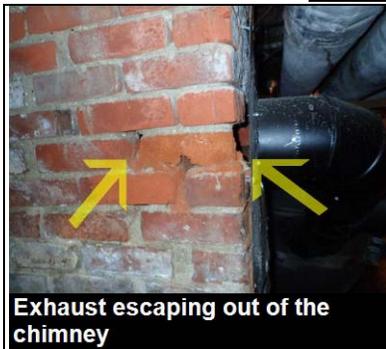
Deterioration of the brick and mortar around the connection to the chimney base; probable exhaust leaking in the basement during basic furnace operation.

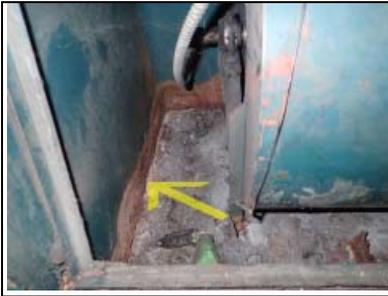
The sheet metal plenum is rusted through at the floor and return air will be drawn from the basement/crawl space into the house.

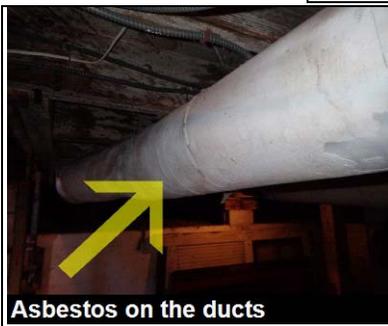
Sheet metal air ducting.
Asbestos-like materials noted on most of the distribution system: *Wrap on the ducts will probably contain some amount of asbestos- caution is needed when handling/removing.*

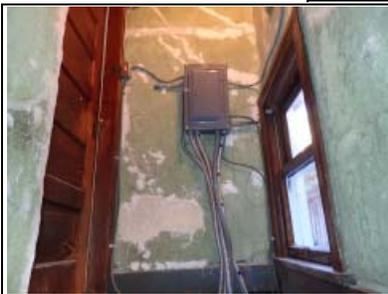
In the Basement stairs. This installation location is considered a safety hazard and the box should be re-located to a suitable location in the basement or in the house.

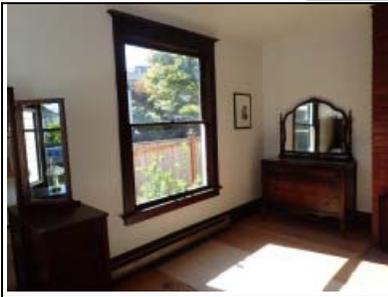
opened. Recommend correcting at least one in each of the bedrooms and main rooms, for egress purposes. Significant repairs/corrections may be needed to restore these windows to their original condition.
Recommend contacting a qualified, licensed window specialist/contractor to evaluate and repair/replace/correct as needed for safety reasons

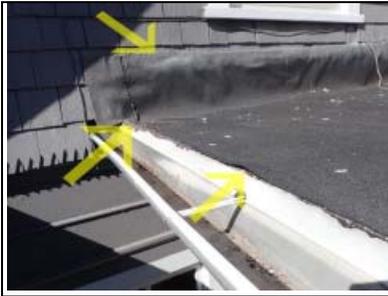
Torch-Down membrane roofing with the following conditions visible:
 - Edges are lifting up on the south side roof; joints filled with silicone? Poorly installed at the housewall also.

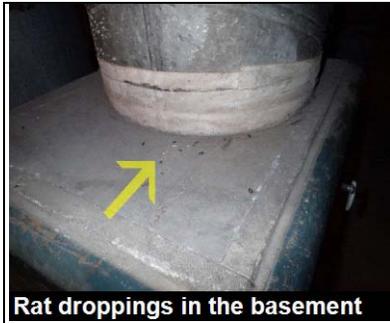
Rat droppings in the basement

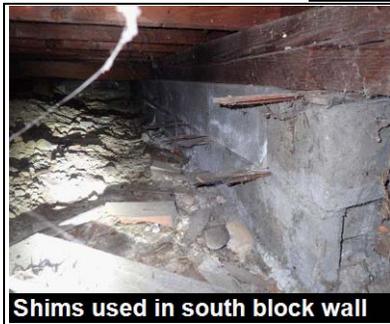
Shims used in south block wall
