# Confidential Home Inspection Report

Prepared for: **Concerned Home Buyer**

**Condo Street  
Seattle, WA 98000**

**February 29, 2016**

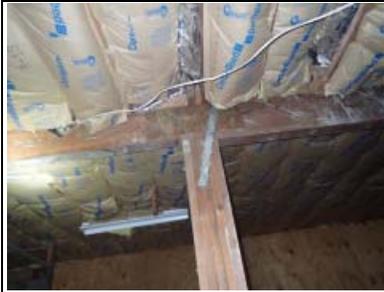
Conditions:	Overall condition- Appears serviceable. No visible evidence of structural issues/problems noted during the inspection. Additional strapping and gusset plates were added to the post and beam connections.
-------------	---

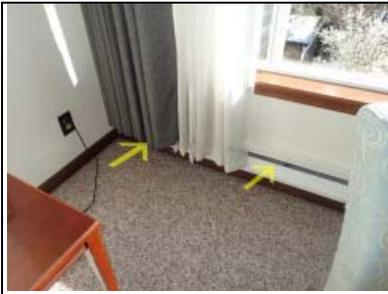
Baseboard Operation:	<p>All baseboard heaters appear to be operational/serviceable at time of the inspection. Thermostat(s) appears to be serviceable. Recommend replacing the old thermostats to regulate heat better.</p> <ul style="list-style-type: none"> <li>- Drapes should not be within 12" of the heaters. Correct installation as needed.</li> <li>- See Wiring section of the report also.</li> </ul>
----------------------	--

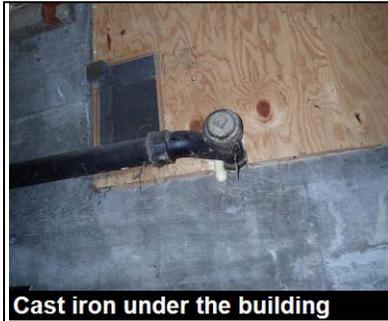
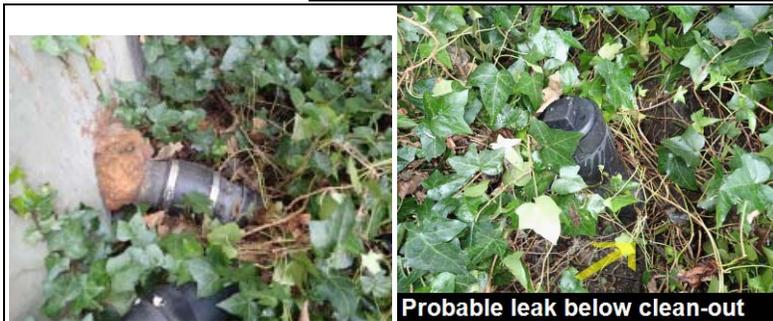
Conditions noted: Overall condition- Appears serviceable. No visible problems detected at this time. No evidence of significant leaks detected or concerns/problems noted at time of the inspection. With the concerns/issues/exception noted during the inspection:  
- Evidence a sewage leak in the main drain-waste pipe on the north side of the building (exterior side yard); probable broken or disconnected drain-waste pipe. Raw sewage detected in the soils around this area. The vegetation in this area would need to be cleared away to determine the exact location. Please refer to the *Sewer Scope report* for information regarding the disconnected sewer pipe.  
Recommend contacting a qualified, licensed plumbing contractor for evaluation and repair/correct as needed.

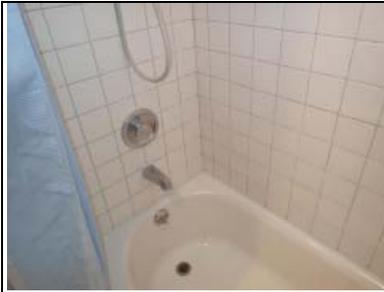
Location:	Hallway.
Type:	Full- Tub & Shower surround combination.
Tub/Shower Enclosure:	Tile- Ceramic/Porcelain/Stone.
Enclosure Conditions:	Overall condition of the tub/shower enclosure appears serviceable. - Vinyl strips used at the tile surround/tub line, instead of conventional grout and caulking. Maintain vinyl strips or replace as needed.

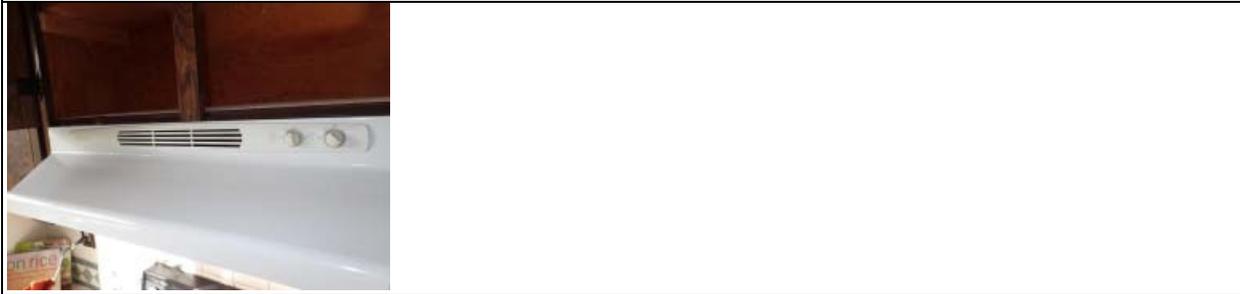
Exhaust Hood/Fan system- Appears operational/functional and appears to be operating as intended. **Re-circulating fan system- vents back into the room** (via a charcoal filter).

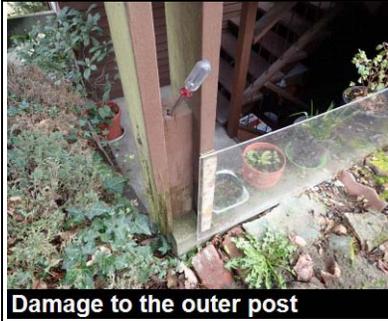
**Damage to the outer post**

Conditions: Overall condition- Appears Serviceable *at this time*, but with fungal rot damage to multiple locations in the steps, railing and outer structural posts. Probable need for replacement of these components in the very near future. Recommend contacting a licensed contractor to evaluate the porch and correct/repair as needed.
