# Confidential Home Inspection Report

Prepared for: **Prudent Home Buyer**

Any Street  
Kirkland, WA 98000

November 2, 2016

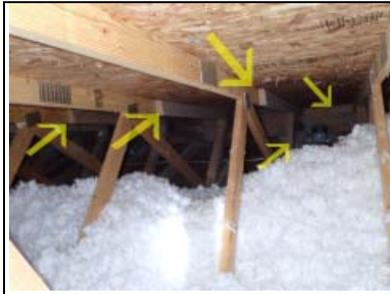
Type:	Engineered trusses; 2x4's (top chord)
Sheathing:	OSB (Oriented Strand Board)
Conditions:	Overall Condition- Appears Serviceable. No visible defects or concerns noted at the time of the inspection. With the notable exceptions/concerns/issues; - The 2x4 roof trusses were apparently modified, located over the front bedroom; the trusses were apparently cut-off at the end and extended to an engineered beam. This appears to be professionally designed and installed. Recommend inquiring with the Seller/Builder about the modifications; recommend obtaining a copy of the approved, modified truss installation for future reference when selling the house.

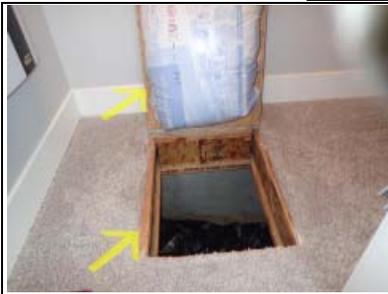
Access Location:	Interior of the house; Entry closet.
Access Conditions:	Access opening/framing to the sub-structure crawl space, appears serviceable and is functioning as intended. - Recommend adding a weather-strip around the access opening to prevent heat loss, and limit airflow between the house and crawl space.

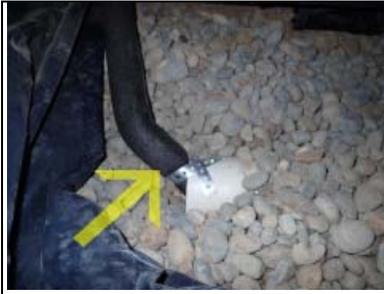
Appears to be serviceable/operational at this time. The drain system at the furnace appears to have been installed properly and will drain as needed. The drain line termination point is located in the crawl space footing drain (not in an obvious location)

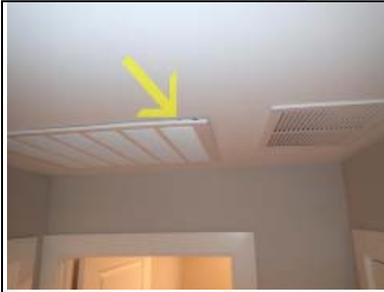
Appears serviceable, heat (and/or airflow) appears to be distributed/provided to all habitable rooms as intended; No Significant problems/issues noted at the time of inspection.  
- The return vent grill is not mounted tight to the ceiling, located in the upper hallway.

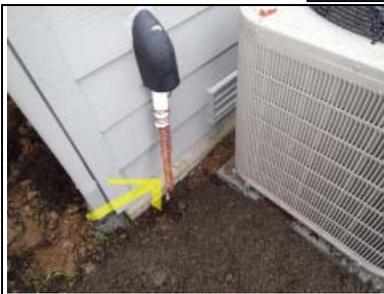
Air Conditioner (A/C); Not fully installed at this time. The system was not tested.

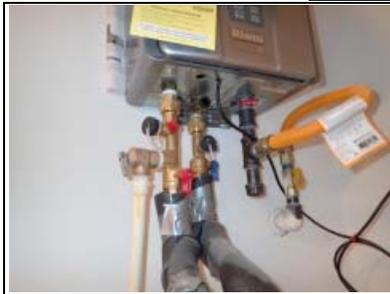
Location:	Garage.
Type and Size:	Tankless; wall-mounted Unit.
Estimated Age:	Original equipment. New.
Gas Pipe/Valve:	Valve is located next to the water heater; Appears Serviceable.
Water Heater Installation:	<p>Overall condition- Appears serviceable;</p> <ul style="list-style-type: none"> <li>- Temperature &amp; Pressure relief valve (T&amp;P or TPR)- appears to be installed properly in the tank. (Note: This is not tested for operation). The overflow discharge pipe, on the T&amp;P valve, appears to be installed properly. This overflow pipe/tube is designed to drain the hot water out of the tank and prevent the tank from bursting. The overflow discharge pipe terminates, to the exterior of the house (visible).</li> <li>- Exhaust vent appears serviceable, no visible issues noted.</li> <li>- <i>An Expansion tank, was not installed at this time.</i> Recommend referring to the Manufacturer's installation instruction to determine if these are required with a closed system.</li> </ul> <p><i>Quote from the Manufacturer's manual:</i> "If a water heater is installed in a closed water supply system, such as one having a backflow preventer in the cold water supply line, means shall be provided to control thermal expansion. Contact the water supplier or local plumbing inspector on how to control thermal expansion"</p>

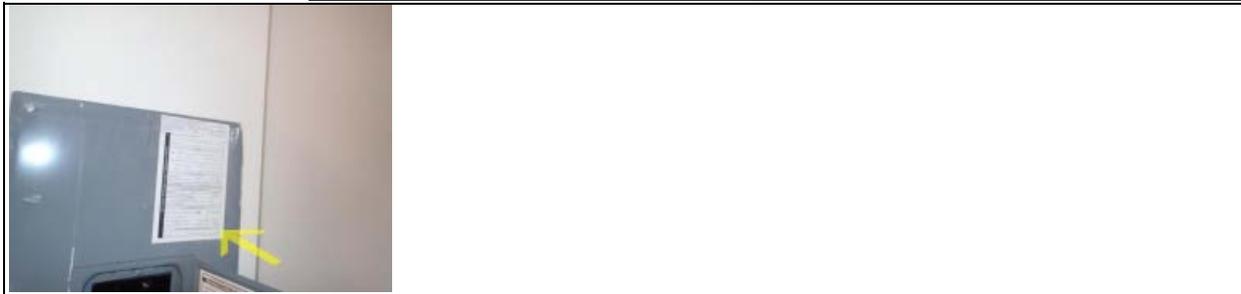
Compliance:	<p>Energy Compliance Certificate, is posted on the electrical panel box at this time (required). This identifies the air leakage rate and insulation factor for the house.</p> <ul style="list-style-type: none"> <li>- Despite openings in the kitchen wall, hardware and weather-stripping missing at the front door and no weather-stripping at the crawl space access opening.</li> <li>- The insulation information has not been provided at this time.</li> </ul>
-------------	---
