# Confidential Home Inspection Report

Prepared for: **Mr. House Hunter**

Any Street  
Lynnwood, WA 98000

March 3, 2016

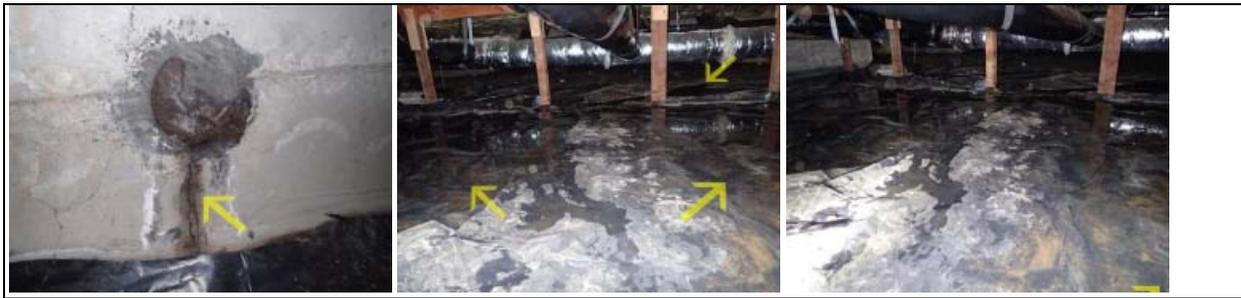
Accessibility into Sub-Area:	Sub-structure crawl space is reasonably accessible- clearances are ample/adequate at this time, in most areas. Entered the sub-area for a full inspection.
Floor Type:	Dirt/Silt-type soils.
Dampness/Moisture:	<p>Evidence of excessive water/moisture conditions in the crawl space. Standing water under/above the plastic vapor barrier; standing water is present in over half the crawl space sub-area (limited access to all areas). Several of the wood posts are below the water level, or are covered with mud-sediment.</p> <p>Water entry through the foundation wall, located under the fireplace area; most of the water appears to be from high ground water.</p> <p>Recommend consulting a qualified, licensed professional drainage contractor for evaluation and recommendation for the best solution on removing/eliminating any excessive moisture conditions that may be present and provide a drainage solution to permanently remove any excess water/moisture from the sub-area. Recommend evaluations of the roof drainage system (dye testing if needed), surface drainage around the house and ground water to determine if these contribute to the water/moisture issues in the crawl space. Recommend eliminating all excessive moisture and conditions that may be present in the crawl space sub-area.</p>

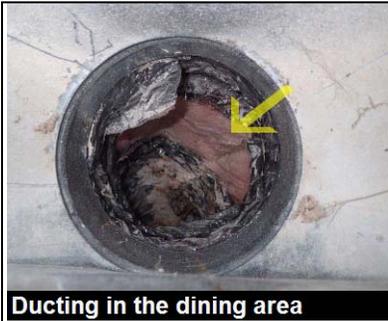
Ducting in the dining area

Type(s):	Sheet metal air ducting, insulated, Flexible round air ducts (insulated)
Overall Conditions:	Appears serviceable, heat (and/or airflow) appears to be distributed/provided to all habitable rooms as intended; With the notable concerns/issues/exception:
Air Quality/Conditions:	Debris noted in the heat/air ducts, visible through the floor registers. Recommend cleaning the ducts as needed.
Concerns/Issues- Metal/Flex ducts:	<p>Conditions noted with the metal/flex ducting:</p> <ul style="list-style-type: none"> <li>- The flex ducting appears to be damaged in the dining room; the inside of the ducting is torn/damaged (fiberglass is exposed). Recommend replacing the flex-ducting as needed.</li> <li>- Recommend replacing the damaged duct insulation in the crawl space as needed.</li> </ul> <p>Recommend contacting licensed HVAC/Mechanical contractor, or handyman, to make further evaluations of the ductwork system. Repair/replace ducting as needed using approved materials and installation practices.</p>

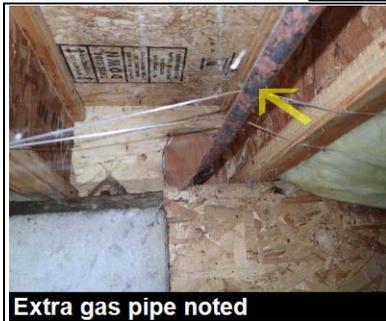
Note: Extra gas pipe noted under the kitchen area (terminates at the outside wall). This may have been designed for an exterior gas connection?

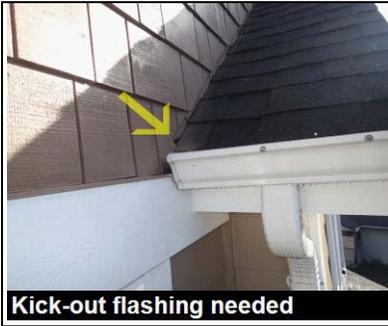
Types noted:	Metal- galvanized, Neoprene/thermoplastic/flex-flashing.
Overall Conditions:	Overall condition- Appears serviceable, no significant issues noted at this time. With the exception/concern/issues noted; - Kick-out flashing is needed at the roof/housewall intersection or junction- located at the end of the step flashing. This will divert water run-off on to the roof or into the gutter system and not behind the siding/cladding or trim.
