Confidential Home Inspection Report

Older Neighborhood

September 26, 2016

Seaview Home Inspections, LLC

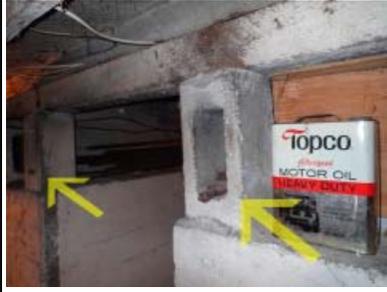
Conditions: Appear serviceable- Overall condition. With the notable concerns/issues/exception:
- The 6x6 posts in the basement are damaged at the base. Replace posts as needed. See WDO section of the report, for additional information of the conditions noted.

- Soils contact to some wood posts/wood blocks, minimal clearance or posts are near soils grade level. Clear the soils away from all wood posts and blocks as needed. Watch for rot/insect damage to the posts in the crawl space area. Replace all damaged materials as needed, using pressure- treated lumber.

- The 6x post appears to be missing, located under the north wall where the lower bathroom is installed. The fungal rot damaged 6x beam is suspended in air, with no apparent post support noted. Recommend adding a 6x post after all the repairs are made to the sub-framing under the bathroom and stair covering
Recommend replacing the post(s) with the proper type/size structural lumber. Recommend using pressure-treated posts where needed. Recommend contacting a qualified, licensed contractor to make further evaluations and make all necessary repairs/corrections as needed.

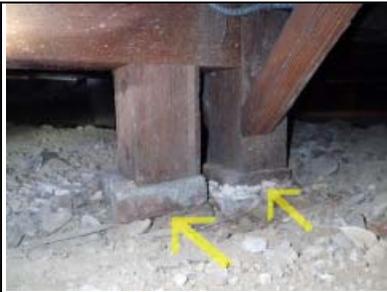
Concerns/problems noted with the footings used at the time of the inspection:
 - Bricks are considered non-conventional* footings materials (used as piers/footings under all the posts in the crawl space area and some of the perimeter framing) and do not provide adequate load-bearing support of the posts and beams. Recommend replacing these components as needed, using conventional footings rated for the proper load-bearing to support the exterior and interior sub-floor framing. Recommend contacting a qualified, licensed contractor to make further evaluations and make all necessary repairs/corrections as needed.

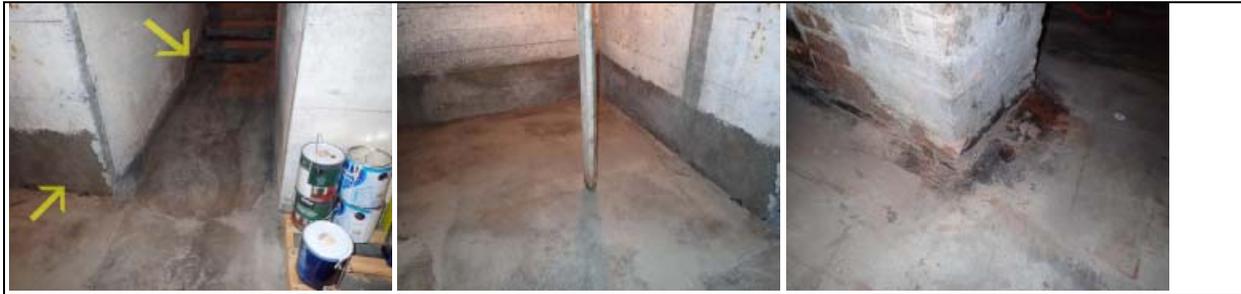
Accessibility of the Basement:	Basement is unfinished. The framing, wiring, plumbing, etc. is accessible for inspection.
Component Conditions:	Interior stairs- Appear serviceable and adequate at this time. (These stairs do not meet current standards- typical for the age of the house) Check the posts and framing, supporting the stairs/landing, for moisture-related damage. Replace as needed.
Floor covering and conditions:	Open concrete slab. General condition- Appears serviceable, no apparent significant problems noted.
Moisture/dampness conditions:	Evidence of past flooding and standing water in the basement area; water damage to the base of the posts and the furnace/sheet metal plenums. Evidence of water-proofing materials and sealants on the walls/floor, on the basement stairs and around the base of the chimney. Water intrusion through the basement steps and probable high water table issues (through the joints in the flooring). Unable to determine if these "corrections" were installed by a professional Drainage contractor(?). Recommend contacting a qualified, licensed Drainage contractor for further evaluations of the conditions in the basement area to determine if a full drainage system is needed for the basement.

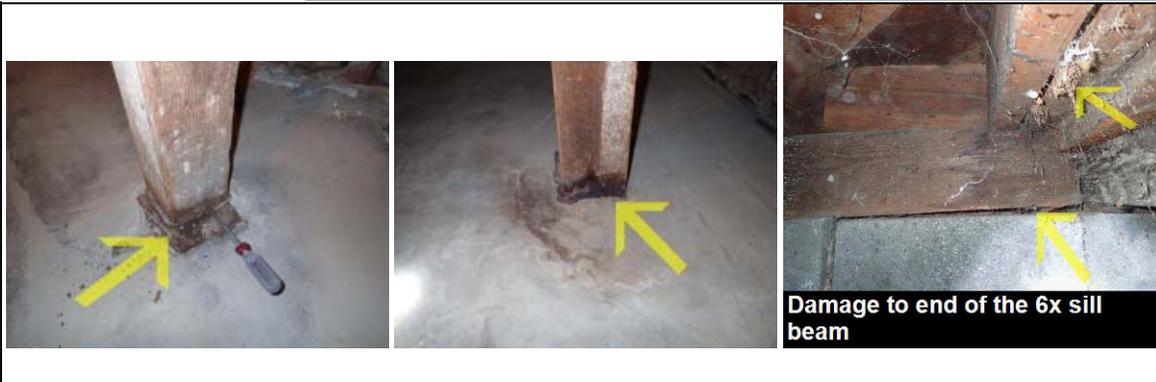
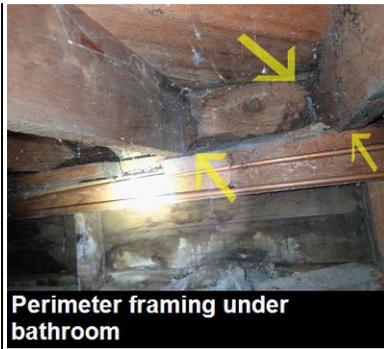
Perimeter framing under bathroom

- The 6x6 posts and wood blocks in the basement flooring (main structural support for the center of the house). Evidence of prior standing water in the basement.
- The 6x sill beam on the north foundation wall, located at the transition between the house and porch. Possible Dampwood termite damage to the wood also noted
- The 6x sill beam, floor and rim joists and 2x4 pony wall framing under the lower bathroom (north wall). Water intrusion from the shed roof and siding installation over the basement stairs.

Remove and replace all structurally damaged wood materials by wood-destroying fungal rot, excessive moisture and wood-destroying insects. All structurally damaged materials shall be replaced/repared to a condition equal to adjacent areas where no damage exists. **All damaged or infested wood must be removed.** All new materials shall be of superior grade. Recommend using ground-contact pressure-treated lumber where applicable. Recommend contacting a qualified, licensed contractor for any structural assessments of the wood members and repair/replace as needed.

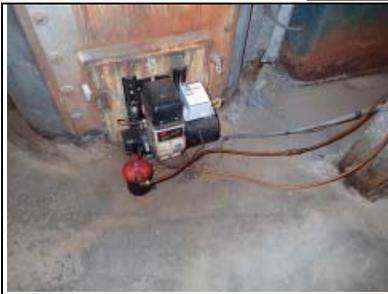
Location- Primary HVAC system:	Basement.
Central Forced-Air system:	Conversion in the heating system noted- Coal to oil burner.
Capacity of Unit:	Unknown rating (unable to determine at this time)
Approximate Age:	Original heating system, with newer oil burner added (<20 years old)

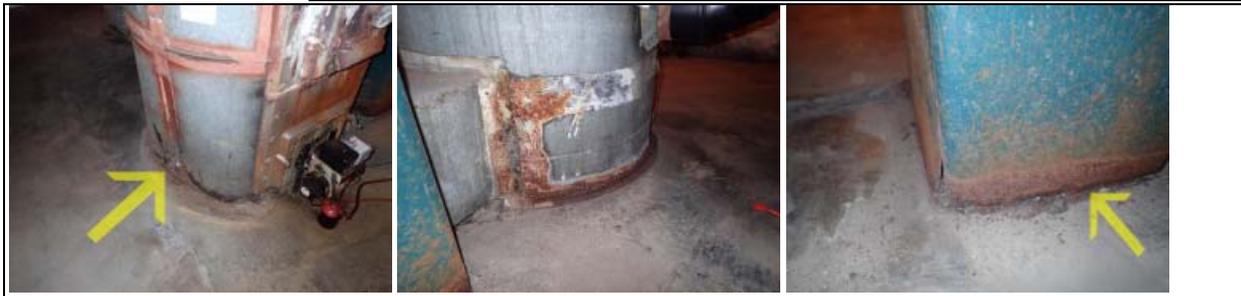
- Significant rust/corrosion and deterioration to the base of the furnace housing and metal ducting in contact with the basement flooring. Evidence of past flooding and standing water in the basement area. Return air from the basement/crawl space will be drawn into the house during basic operation of the heating- ***this is a health/safety hazard.***
- The exhaust vent appears to be installed poorly at the chimney base. Deterioration of the bricks and mortar at the chimney connection.

The heating system was not tested at this time, with the potential for exhaust to enter into the basement and house. Unable to determine how the condition of the heat chamber and was it effected by the past flooding in the basement (potential safety issues).
Recommend complete removal and replacement of the entire heating system for the house for safety reasons. Due to the asbestos on the ducting in the basement and in the house, the costs for removal of this old system may be significant. Consult with qualified and registered Asbestos abatement contractor about removal of this system and ducting. using approved methods and acquiring the proper permits.
Recommend contacting a qualified, licensed HVAC contractor for installation of a new HVAC system in the house.

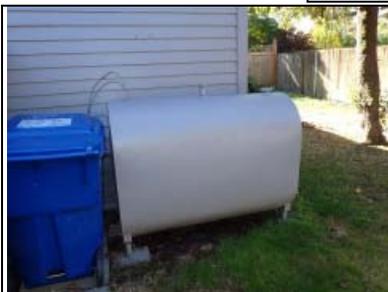
Back Yard- above ground tank visible.

The above-ground tank currently in use for the house heating system. Recommend inquiring with the Homeowner about possible past issues or problems with the tank.
- There is evidence which indicates an oil tank buried in the south side yard also. Oil filler lines in the basement (2 sets) running to the side yard. Inquire with the Seller/Homeowner about current status of these oil tanks. Recommend locating and decommissioning the tank/system as required by law, in this jurisdiction, if needed.

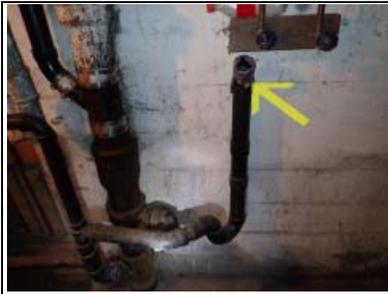
Overall condition- Appears serviceable. No visible problems detected at this time.
- The unused washer stand-pipe should be capped off in the basement.
Note: Newer clean-out cap in the soils.

Recommend contacting a licensed plumbing contractor or Sewer Inspection company to perform a side-sewer inspection. Due to the age of the house and the type of drain-waste pipes used in these older homes, there is a potential for problems/concerns. This will help insure that the sewer pipes, from the house to the street, are clear and functional.

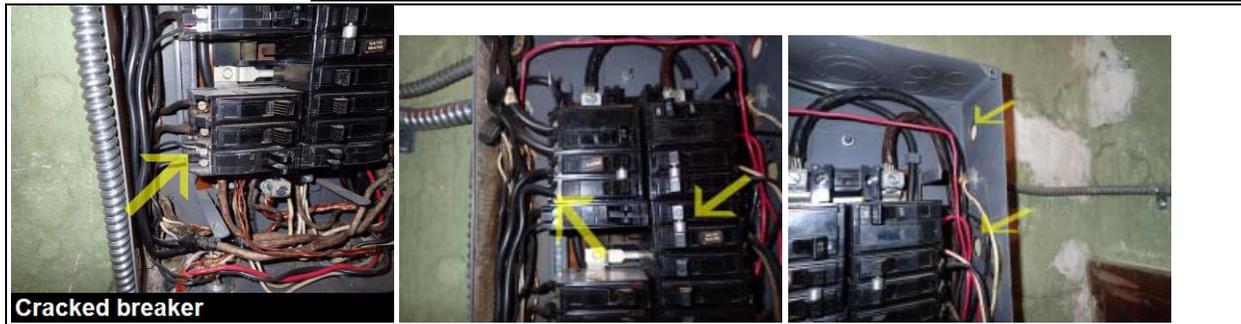
- 20-amp single-pole split breaker is cracked/damaged
- 40-amp double-pole breaker used for the Range; #8 tinned-copper solid wiring used? Is this older wiring rated for this type appliance and is it safe?
- 20-amp double breaker for the water heater; under-rated wiring and breaker for this appliance. Recommend using #10 copper wiring and 30-amp breaker to match the wattage rating of the appliance.
- Unused openings in the panel box should be capped off or sealed for safety. Burn marks in the panel box- prior issues?
- Unused openings, in the panel cover, are missing approved protection; recommend installing plastic knock-outs to protect all openings.
- Double- lugging visible at the Neutral bus bar; Neutral wires are double-lugged at the same bar. Separate neutrals on the bus as needed.

Electrical system appears outdated by today's standards. Recommend upgrading the electrical service and panel box as needed for safety reasons. Recommend having a qualified, licensed electrical contractor make further evaluations of the panel box and components, and make all necessary corrections, as needed, for safety.

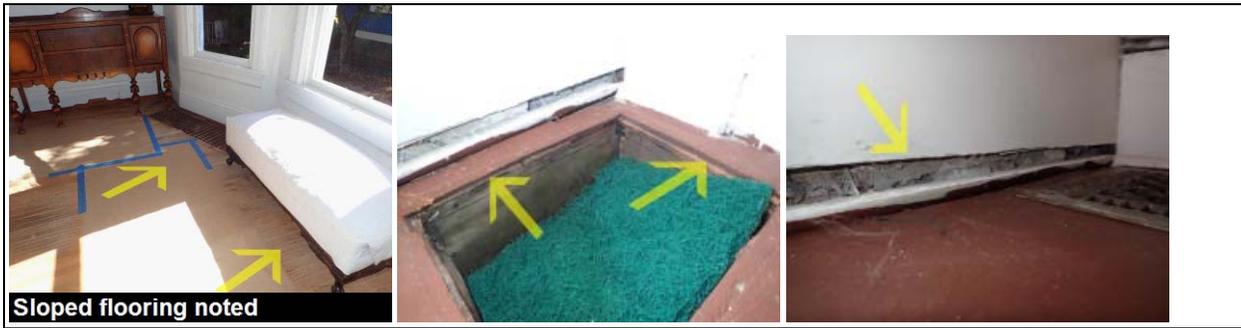
<p>Overall condition- Appears serviceable, with no significant issues noted. With the concerns/issues noted;</p> <ul style="list-style-type: none"> - Sloped and uneven flooring in the dining room and back bedroom and bathroom; these sections of the house appear to be additions and were added after the house was originally built. The sub-framing installation was modified in some areas, with concrete blocks added (post and piers may have been removed under the dining area). Post and pier is still present under the master bedroom/bath area, with poured concrete added around the piers. See the Structural section of the report for further information. - Sloped/uneven flooring in the living room/entry may be from modified perimeter framing; post and pier may have been removed and concrete blocks added to support the perimeter sub-framing. - Evidence of moisture-related damage to the hardwood flooring in the dining area. Discoloring in the exposed flooring and cupped/buckled flooring noted. - Overlay noted in the upper middle bedroom floor- possible plywood or pressboard flooring added (and dented/damaged in multiple locations) - Sloped flooring around the living room fireplace hearth and upper middle bedroom; separation where the original floor and the lath/plaster wall was installed. This appears to be evidence significant movement in the sub-structure framing through the center of the house. The chimney and hearth remained in place, and the sub-floor framing and stud wall framing settled, with the notable fungal rot damage to the 6x6 posts in the basement. This may also be exaggerated with the movement of the framing around the perimeter of the house where the additions were added.

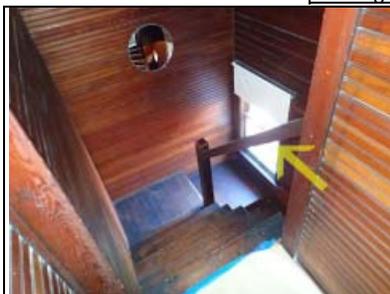
Interior stairs- Appear serviceable. Note: The stairs do not meet current building standards.
 - Stair handrail appears serviceable for the main stairs. However, the railing does not meet current standards and should be improved.
 - The back steps are adequate, but the railing installation is poor for the upper stairs and missing on the lower stairs. Recommend installing and/or re-building the railing for safety reasons.
 - The basement stairs are adequate also, but there is no railing for these stairs. Recommend adding for safety reasons.

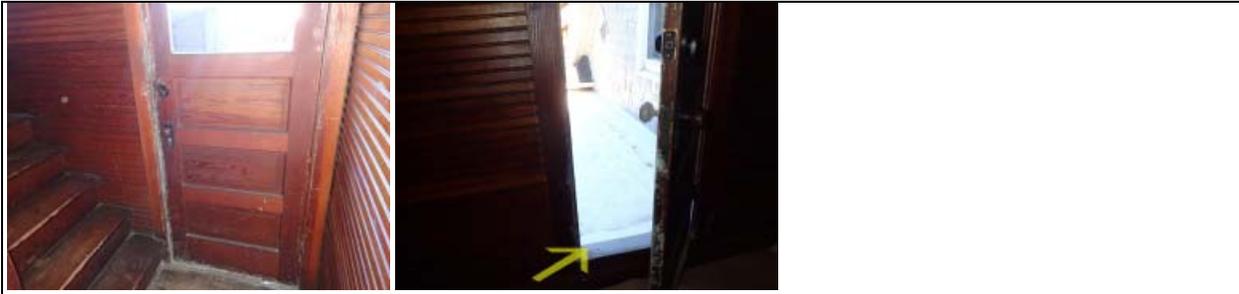
Main Entry Door:	Metal Overall condition- Appears serviceable and operating properly. Weatherstripping around door appears serviceable.
Exterior Door:	Located in, the Kitchen; Metal, w/Glass. Overall condition- Appears serviceable. Weatherstripping around door appears serviceable.
	Back hallway (to porch). Wood- Panel, w/Glass. Overall condition- Appears serviceable. Weatherstripping appears to be: worn/inadequate or ineffective as installed- does not prevent heat loss. (Note: Evidence of duct tape and plastic around the door at one point)
	Upper Hallway (to the roof/deck?). Wood- Panel. Overall condition- Appears serviceable. Weatherstripping appears to be missing, with excessive gaps and no threshold noted, with probable heat loss. Recommend correcting the door installation as needed.

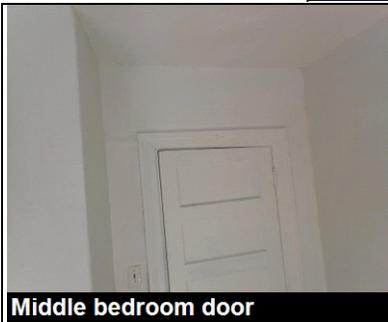
Middle bedroom door

Interior Doors:	Overall condition- Appears serviceable/operational. With the exception/concerns/issues noted; <ul style="list-style-type: none"> - Unable to operate pocket door at this time; door may not be on the track completely. - Door frames are not square in the upper bedrooms, with significant movement in the wall framing and door opening. The doors were modified to fit the door frames. Recommend replacing the doors and frames as needed (Note: If the floors are leveled, the interior doors may not function)
-----------------	---

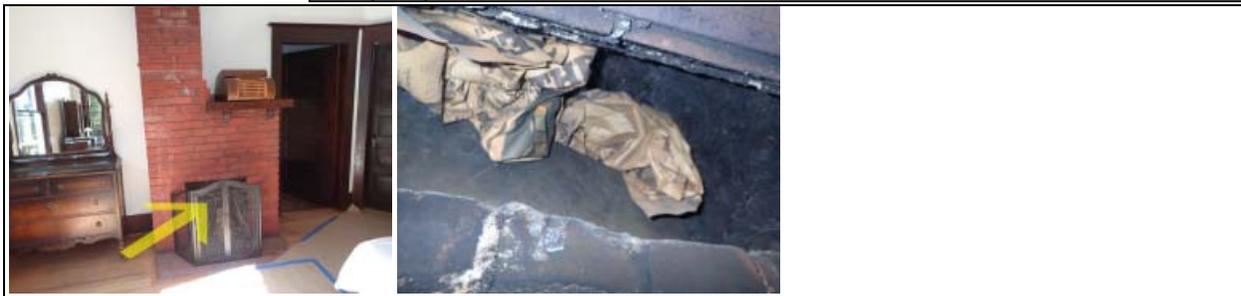
Fireplace #1:

Location:	Master Bedroom.
Type:	Masonry.
Conditions:	<i>This is not a functional fireplace; there is no chimney above/through the roof. This is a potential safety hazard and should not be used for any reason.</i> The flue is currently stuffed with newspaper to prevent heat loss. Recommend blocking this off completely and sealing off the chimney throat to prevent usage. Recommend contacting a qualified, licensed chimney sweep/fireplace contractor for evaluations.

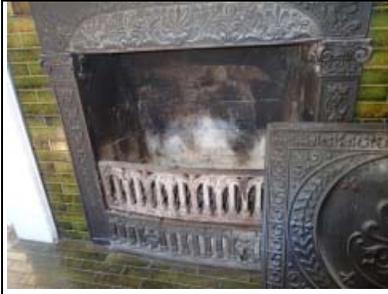
Fireplace #2:

Deterioration to the firebox from use; no damper is present with style (metal cover plate used). This style fireplace may not draft well, recommend limited use. Recommend cleaning the fireplace/chimney prior to use. Contact a qualified, licensed professional chimney sweep for cleaning and a Level 1 inspection (Routine Annual Inspection)

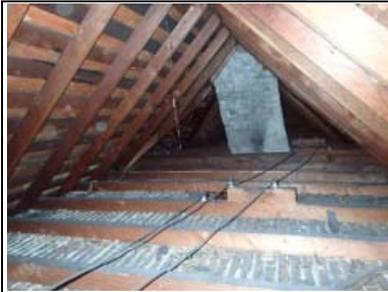
Access Location(s):	Bedroom, Closet.
Accessibility:	Scuttlehole opening (in ceiling). Entered this area for a visual inspection. Side attic spaces were partially finished off.

Overall Conditions:	Water staining noted in the attic space during the inspection- appears to be inactive, old and/or dry at the time of the inspection. Evidence of rodent and animals in the attic space.
---------------------	--

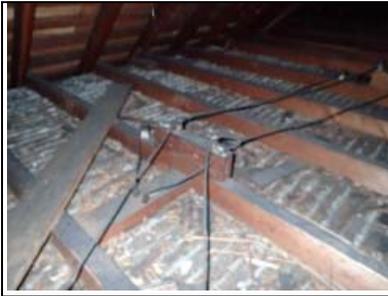
Conditions:	No insulation is provided in the attic spaces at this time. Recommend adding insulation in the attic spaces (upper space and side attic space) to cover all areas and to increase energy efficiency. Recommend increasing the insulation to reduce heat loss from the house. Current building standards is R-49 value in the ceilings. The Knob-n-Tube wiring can be covered if it was inspected and clearance was provided by a qualified, electrical contractor. See Electrical section of the report also.
-------------	--

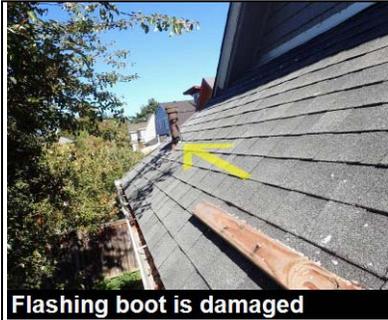
Overall condition- Appears serviceable, no significant issues noted at this time. With the exception/concern/issues noted;
- The neoprene flex-flashing, located at the plumbing vent stack (back bathroom), appears to be torn/damaged and needs replacing.

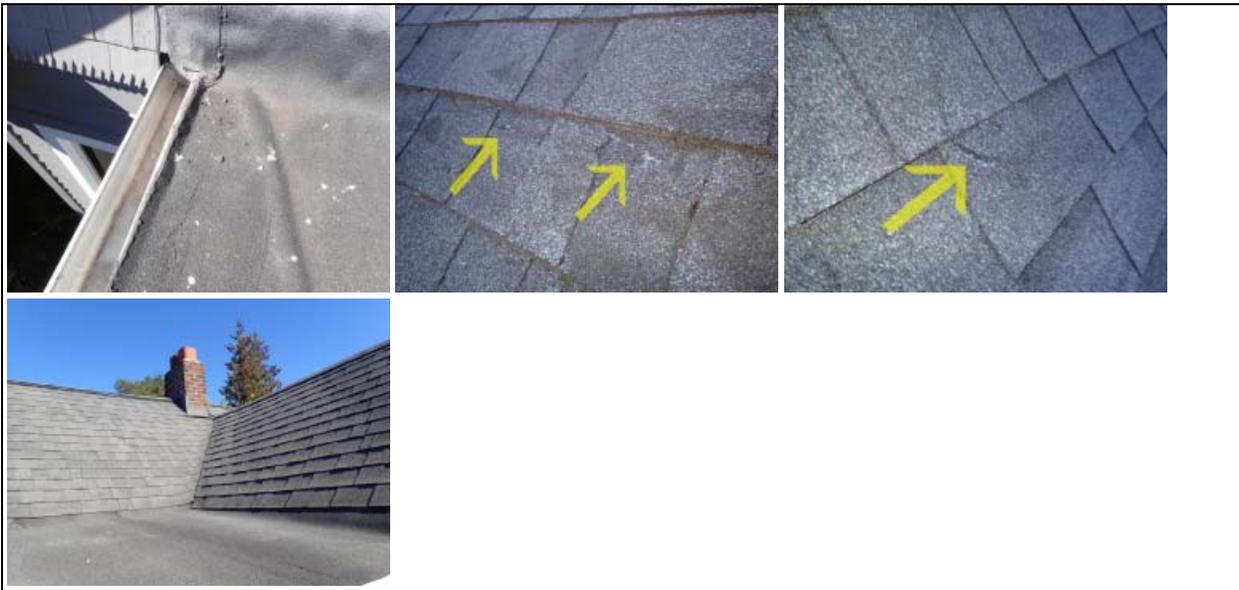
General condition- Appears Serviceable; conditions are based on the age/type and the typical wear of the roofing material. With the concerns/issues and/or conditions noted, which warrants further evaluation:
- The membrane roofing on the lower south side (over the dining area) is buckling/lifting and appears to be installed improperly (and is currently showing signs of wear). Recommend replacing this section of the roofing as soon as possible.
- Shingles that have been gouged are prone to wind damaged and will wear faster- watch for wind-related damage to the shingles.
Recommend having a qualified, licensed roofing contractor evaluate the conditions noted and repair/replace/correct as needed.

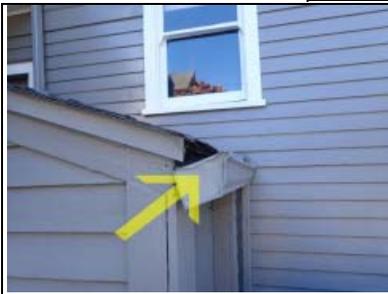
Metal gutters; Overall Condition- Appears serviceable. The overall gutter system appears to be controlling the water run-off as needed. With the concerns/issues noted;

- Dented gutters in few locations- correct/repair, or replace as needed.
- The gutter on the lower shed roof (basement stairs) is tipped inward and will leak water into the basement.
- Debris in the gutters (may hold water)- recommend cleaning the complete gutter system and check for leaks. Recommend detaching the downspout drain pipes when cleaning, so that debris does not drain into the underground drain system.

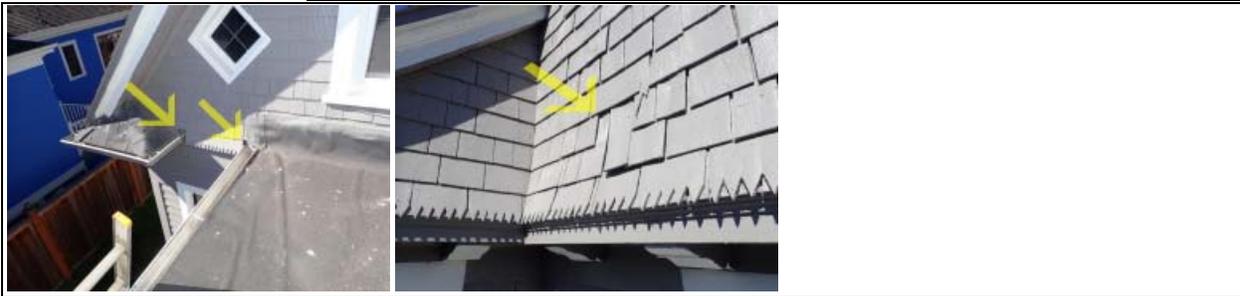
Overall Condition of the siding materials- Appears Serviceable, and the exterior cladding appears to be performing as intended. With the notable concerns/issues/exception;

- Openings in the housewall where the gutters are incorporated into the housewall. Potential for water intrusion in to the house wall, as well as, potential rodent entry into these areas?
- Siding is missing in random areas; replace missing siding as needed.

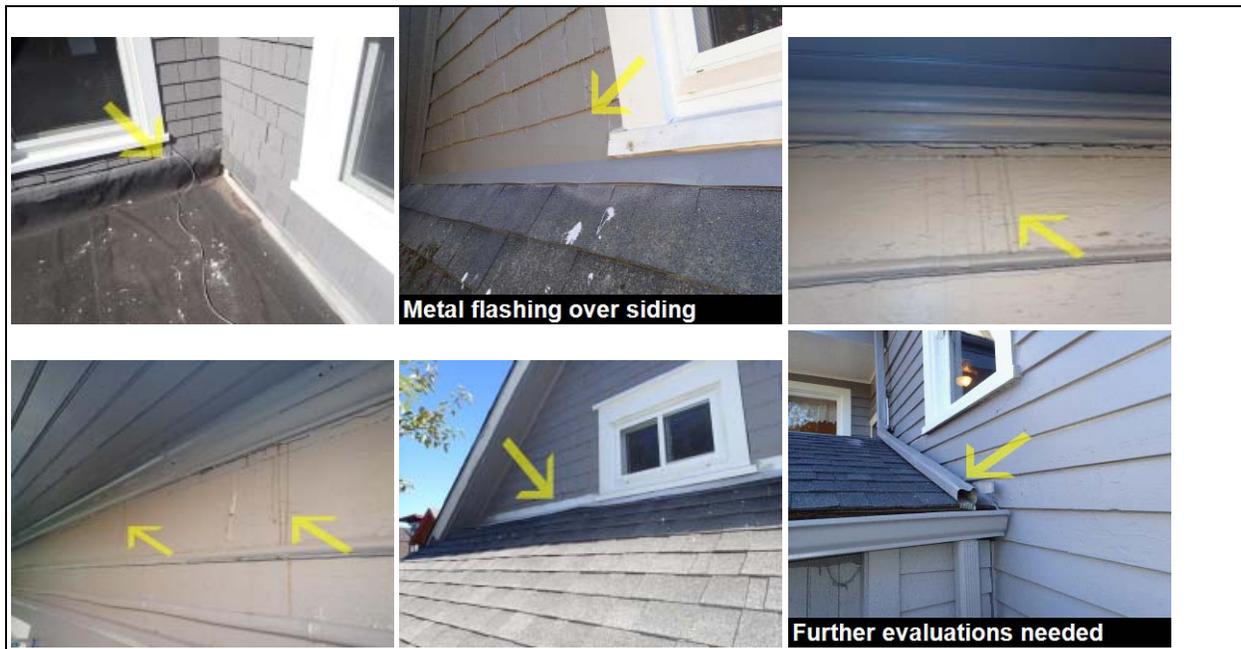
- Unable to determine if there is flashing present, or installed properly, at the shed roof/housewall joints over the exterior basement stairs. Evidence of water intrusion into the roof framing, wall framing, and sub-floor framing, with fungal rot damage in multiple locations. Recommend installing further evaluation of the roof/housewall flashing in all locations and repair/correct as needed, to shed water properly. See WDO section of the main report for further information.

Recommend a qualified, licensed siding contractor/specialist to evaluate the conditions observed and repair/replace as needed.

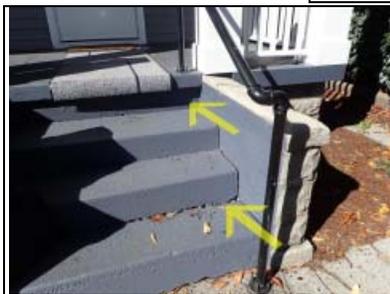
Porch #1:

Location:	Front.
Type:	Concrete steps and foundation; Wood-framed deck structure.
Conditions:	Overall condition- Appears Serviceable. - The steps with irregular and excessive step rise noted; this is a tripping hazard. Recommend rebuilding the steps as needed.

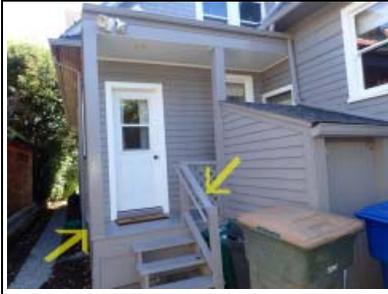
Porch #2

Conditions: Overall condition- Appears Serviceable. With the issues/concerns noted.
- No railing on the side of the porch- potential walk-off hazard. Recommend adding a guard rail as needed
- The stair railing is adequate, but should be on the open side of the steps.

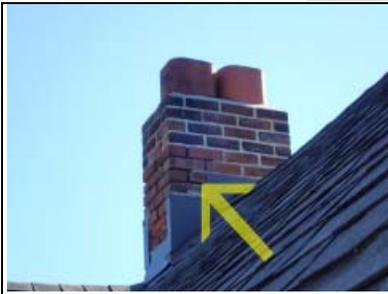
Conditions: Appears Serviceable; With the notable exceptions/concerns/issues;
The mortar is missing on the north side of the chimney; tuck-pointing is needed.
- The mortar is missing around the oil furnace exhaust vent penetration in the basement also.
Exhaust gases will escape into the basement with the current conditions noted.
Recommend contacting a licensed masonry contractor for evaluations and repairs as needed.

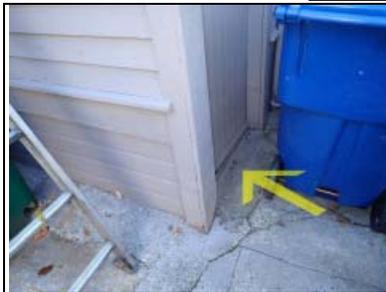
The exterior stairs are at grade level, with the potential for water into the basement
The gutter is not connected properly; the upper roof discharges on the shed roof, with improper flashing and drainage off the roof. Openings through the housewall siding allowing water intrusion into the perimeter sub-floor framing. See the WDI/WDI section of the report.

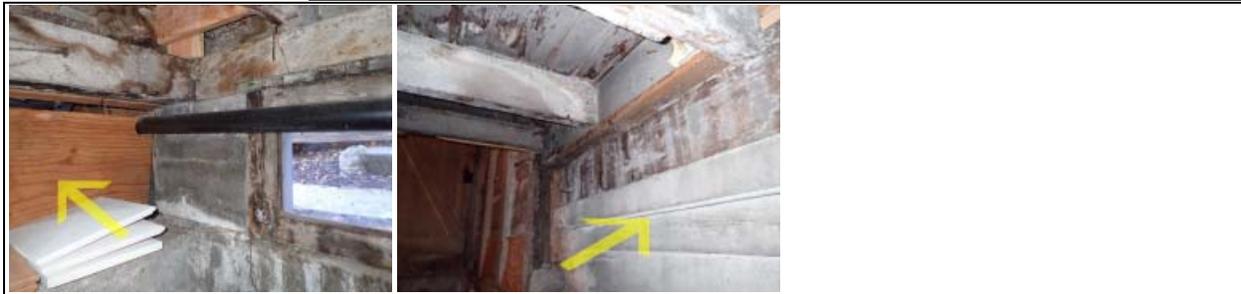
Area(s):	Crawl space area under the kitchen area.
Accessibility:	Plywood and planking was installed to cover over this section of the sub-floor framing. Evidence of prior repairs to the pony wall framing and sub-floor framing in this area- viewed through a small opening in the plywood skirting only.

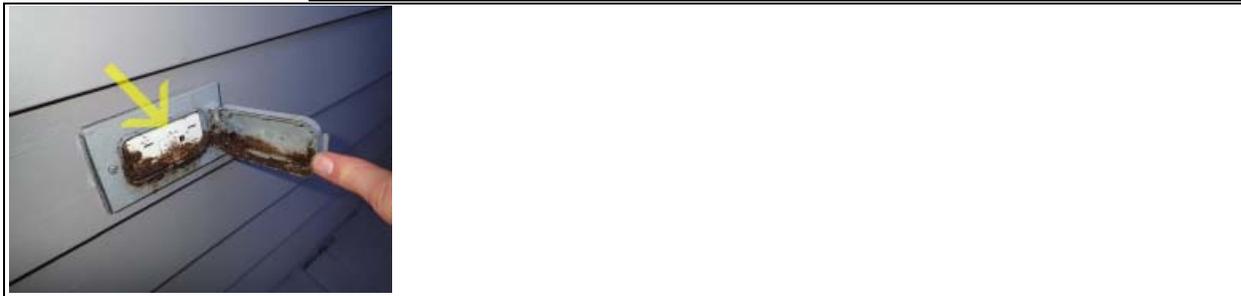
Type of Infestation(s):	Nuisance ants noted at the back electrical outlet.
-------------------------	--

Recommendations:	Contact a licensed Pest Control/Management company about treatment and control/spraying for these insects.
------------------	--

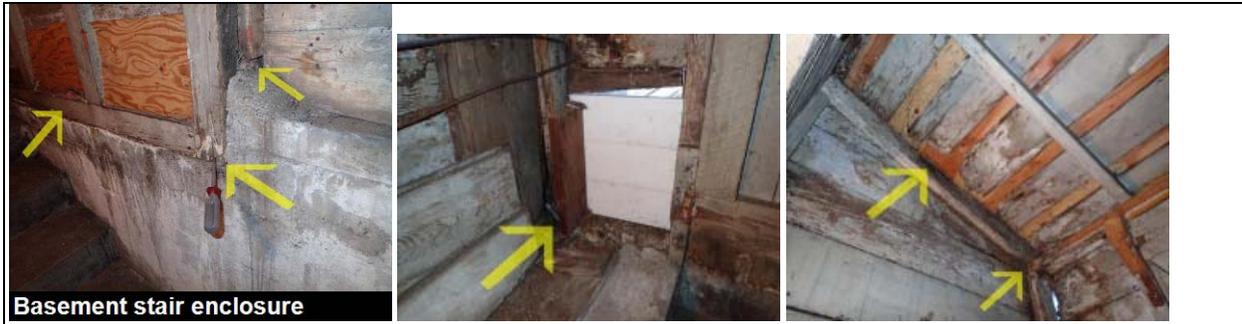
Photo #1

Water intrusion and damage to the shed roof and wall framing around the basement stairs enclosure. Flashing and roof drainage issues, as well as surface drainage issues and wood in contact with the concrete.

Basement stair enclosure
